Tree Risk Assessment

Town of Westport Public Works
110 Myrtle Ave
Westport, CT 06880

Jesup Green
20 Jesup Rd.
Westport, CT 06880

April 8, 2024

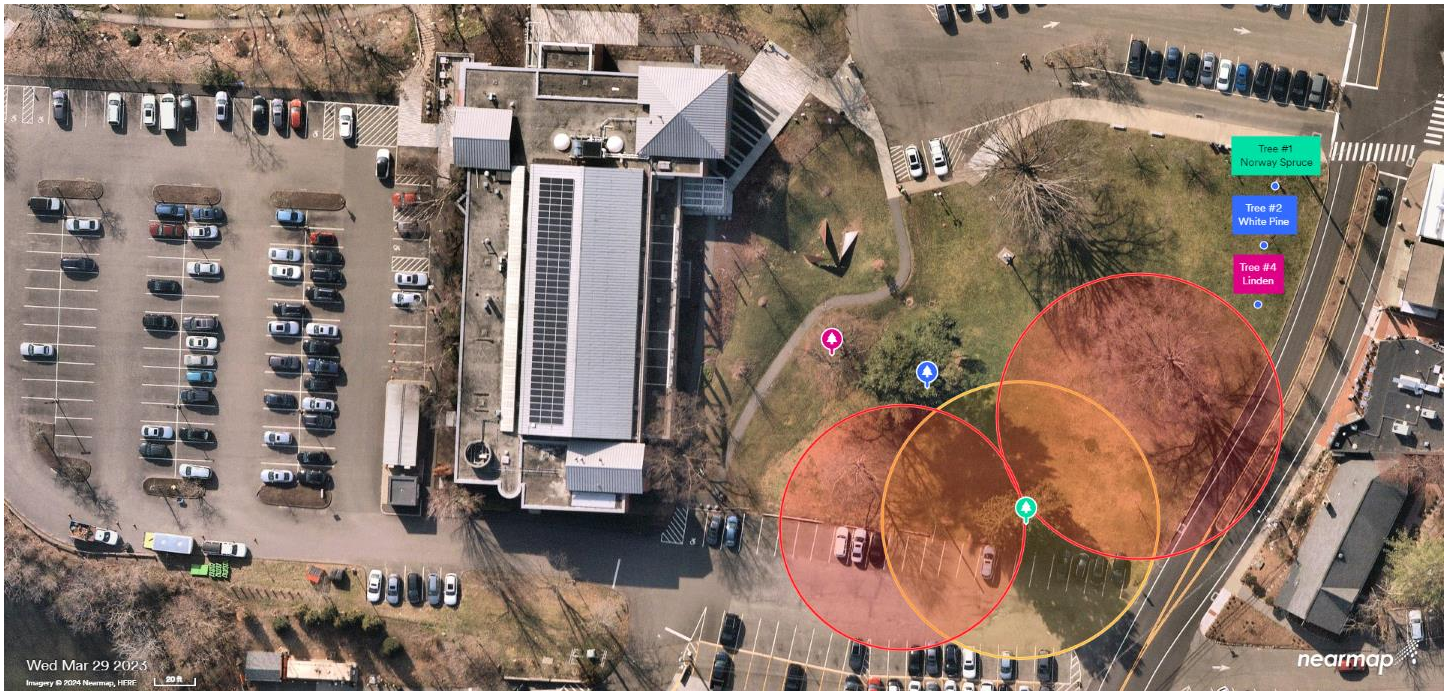
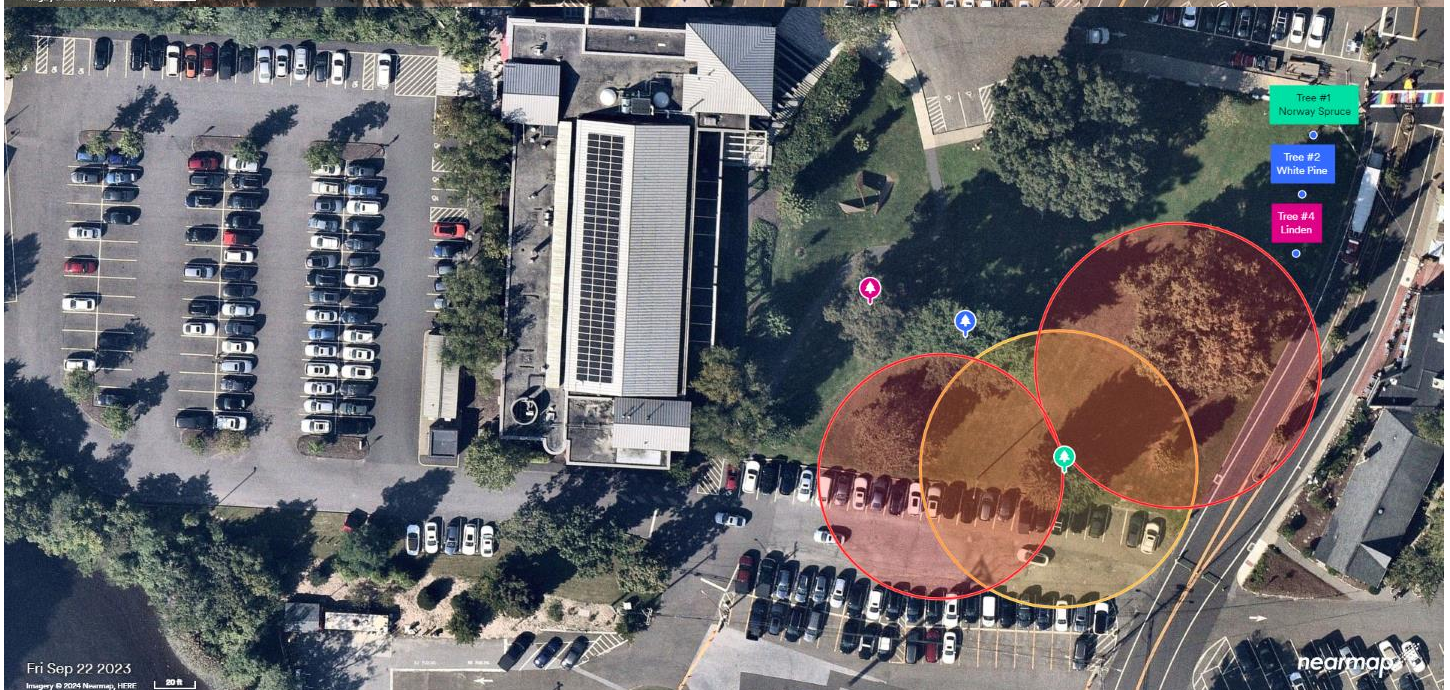
The Norway spruce has the following targets within its failure zone (winter and summer). These zones depict likely areas of failed portions of tree and or tree debris that may impact surroundings. This is based on tree height, lean, and failure points.

- Yellow circle: Whole tree failure, one times the height.
 - Parking lot and greenspace.
- Red circle: Individual stem failures.
 - Parking lot, greenspace portion of roadway.

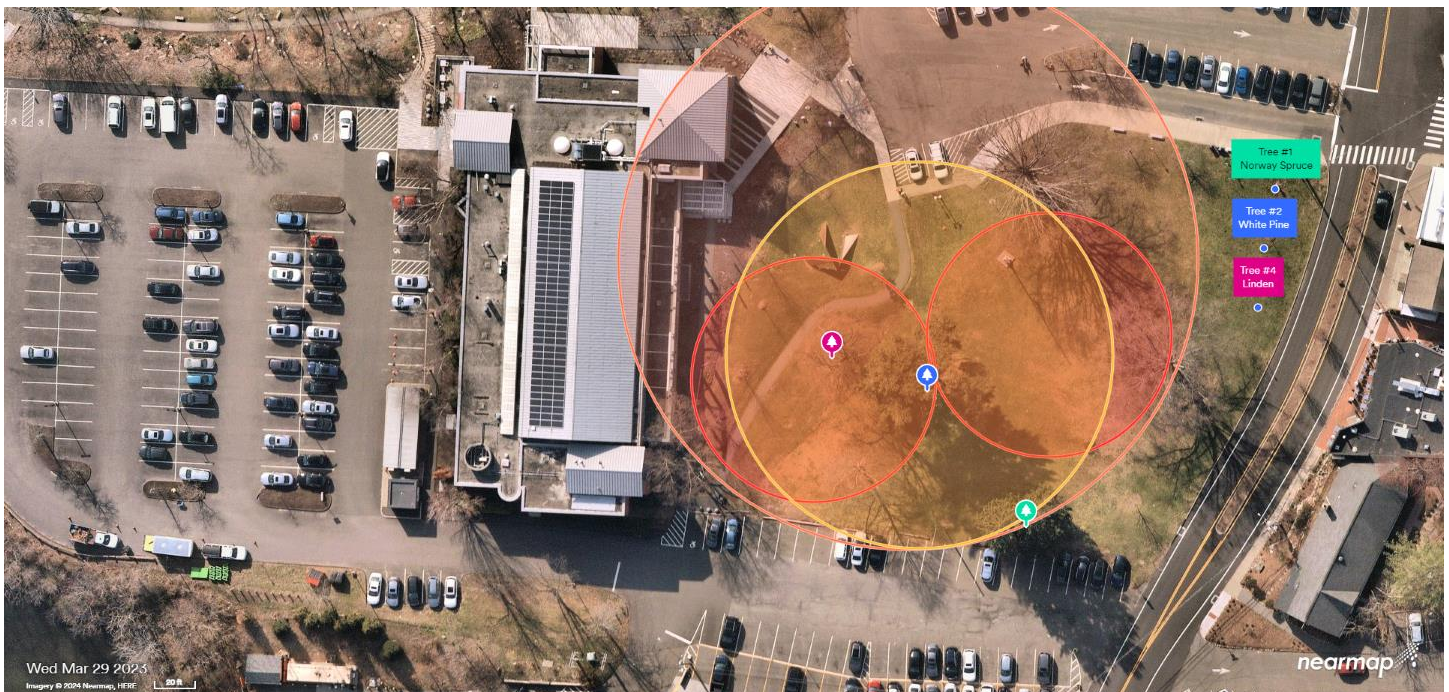
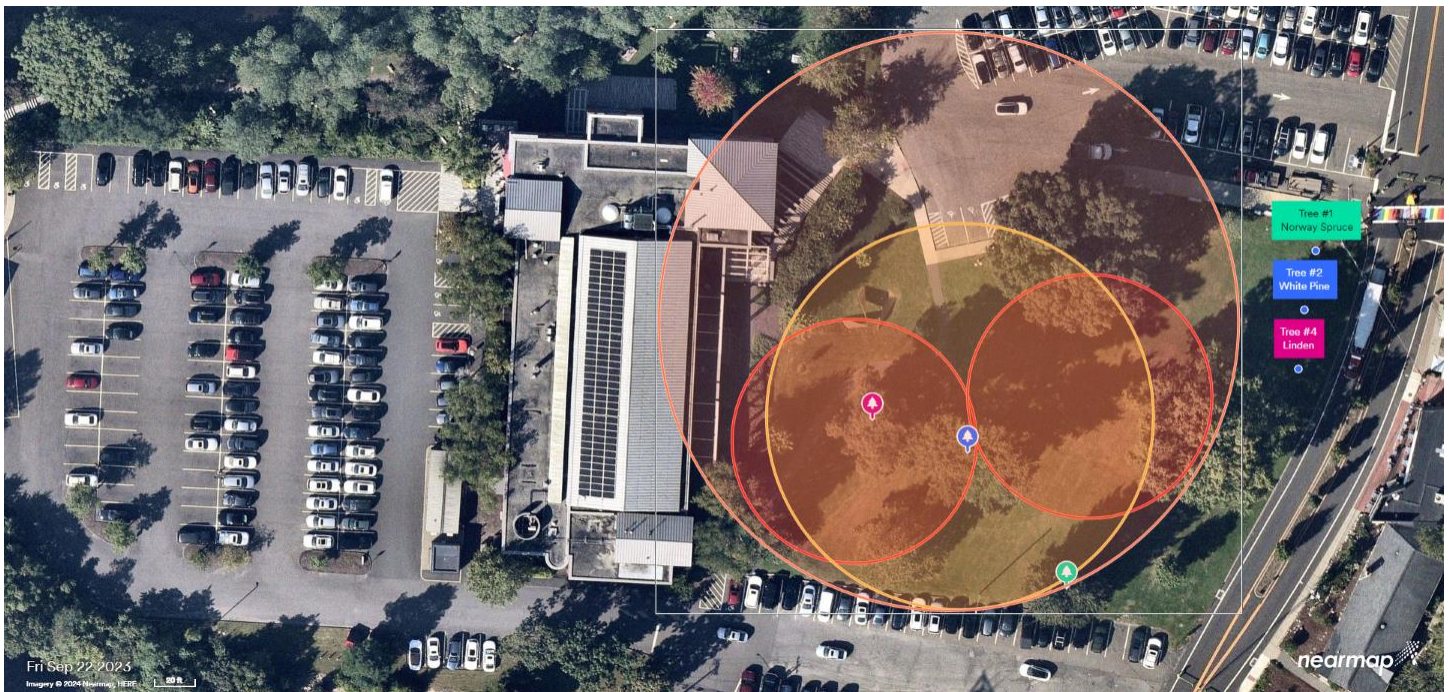
The White pine has the following targets within its failure zone (winter and summer). These zones depict likely areas of failed portions of tree and or tree debris that may impact surroundings. This is based on tree height, lean, and failure points.

- Yellow circle: Whole tree failure, 1X the height.
 - Walkway, green space, parking lot, adjacent trees, small structures.
- Orange circle: Whole tree failure, 1.5X the height (increased target zone based on tree height and species)
 - Walkway, parking lot, building, small structures, adjacent trees.
- Red circle: Individual stem failures.
 - Walkway, adjacent trees, green space.

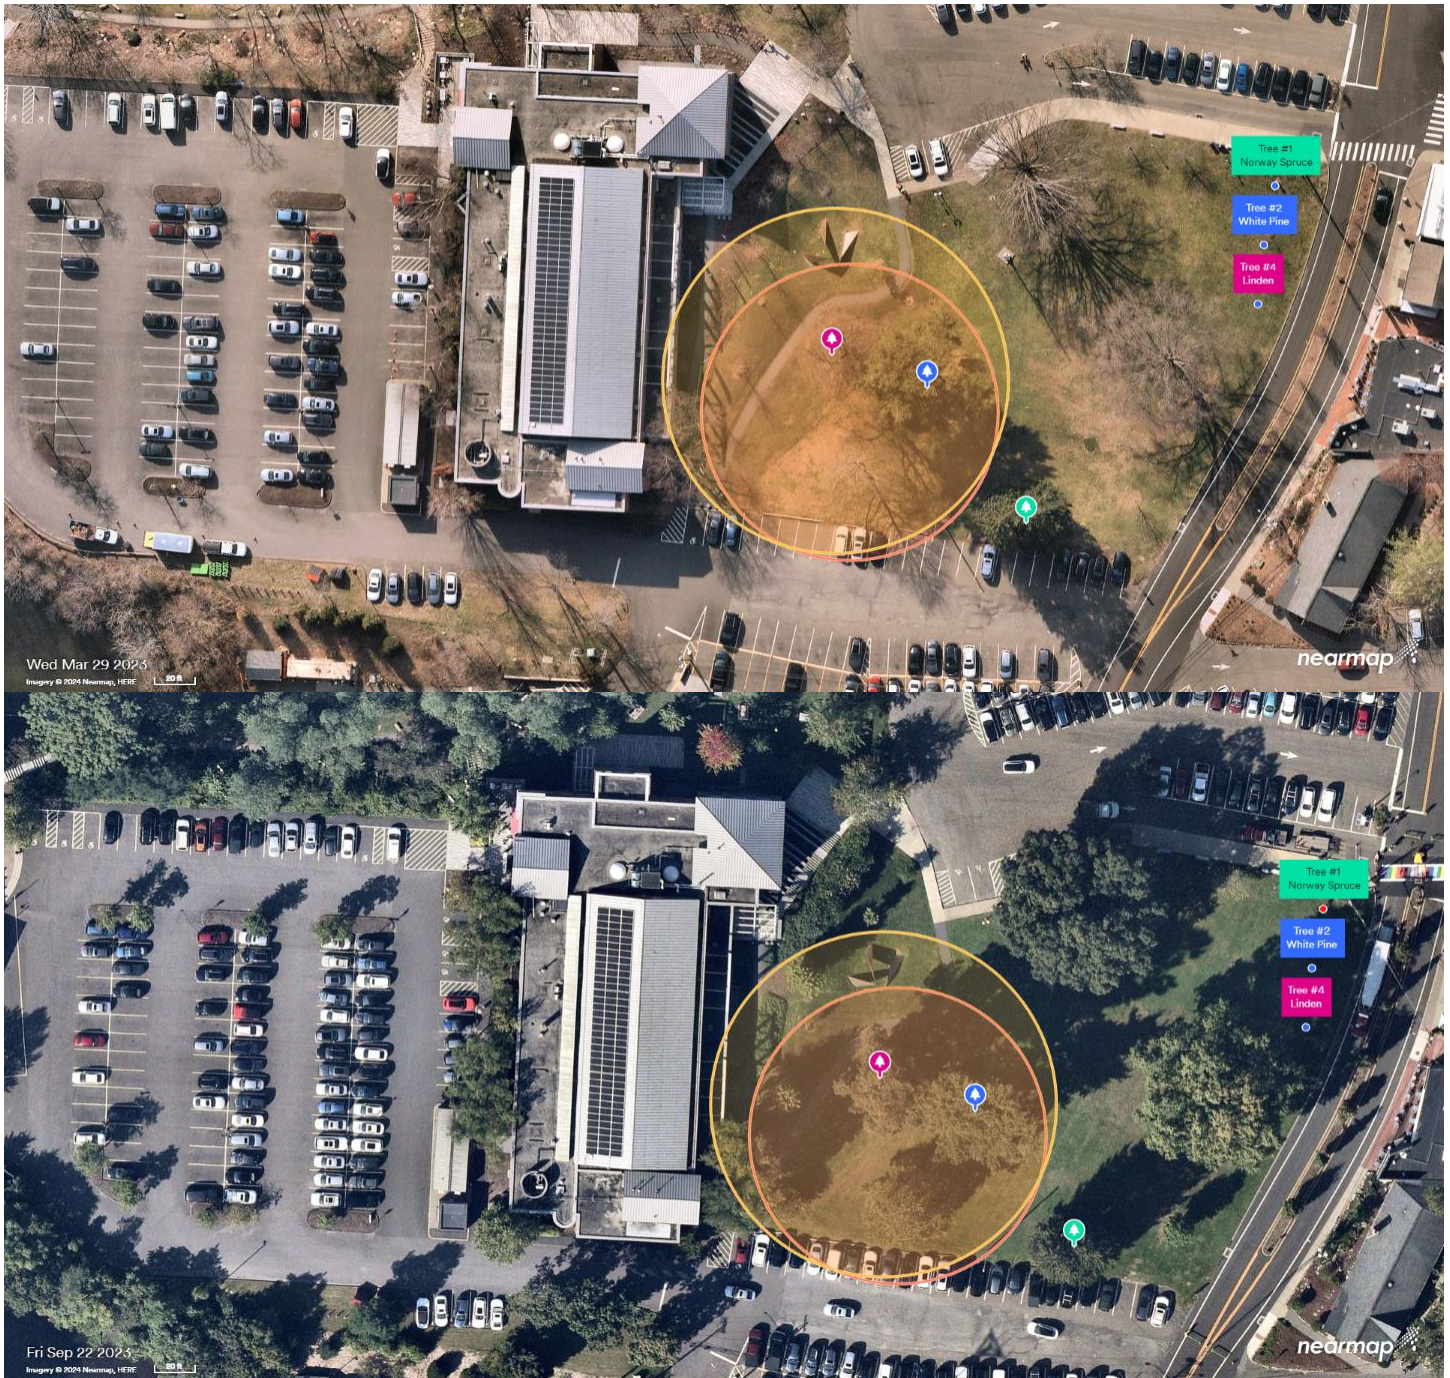
The Linden has the following targets within its failure zone (winter and summer). These zones depict likely areas of failed portions of tree and or tree debris that may impact surroundings. This is based on tree height, lean, and failure points.

- Yellow circle: Whole tree failure, 1X the height.
 - Walkway, adjacent trees, small structures, Parking lot.
- Red circle: Individual stem failure.
 - Walkway, adjacent trees, small structures, Parking lot

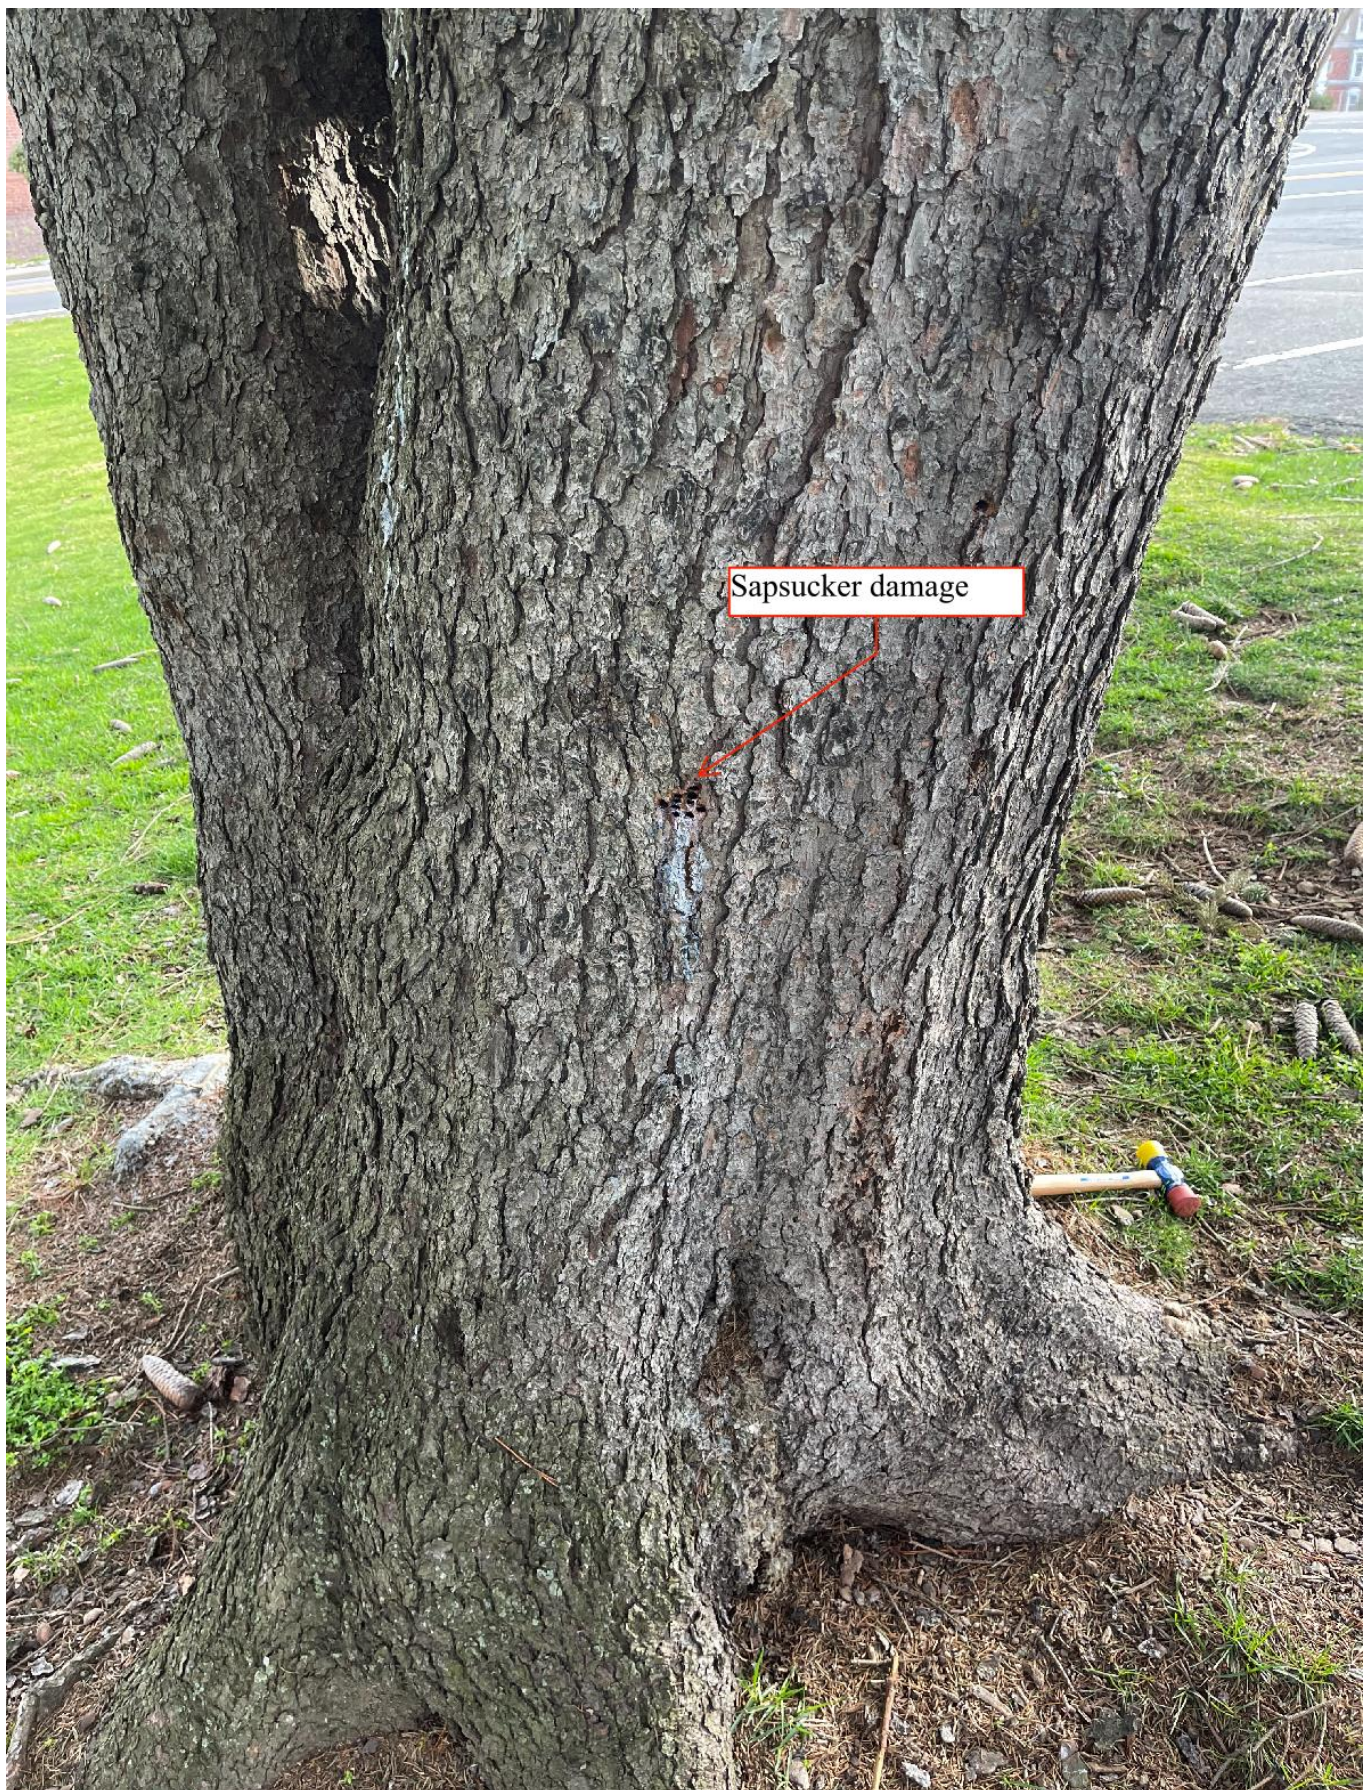
The Norway spruce is located at the eastern side of the green adjacent to the parking lot (appendix A). The tree is approximately 65-feet tall with **codominant** structure (appendix B photo 2). The south stem measures 28-inches in **diameter at breast height (DBH)** while the north stem is 21.5-inch DBH. Each stem had an approximate lean of 20-25-degrees. The south stem has secondary large diameter branch growing above where the two main stems intersect. Oozing sap was observed in multiple locations. The origins of all the sap could not be identified, though some of the observed damage was consistent with damage from a type of a sap sucking bird (appendix B photo 1).

Photograph 1: Norway Spruce- Sapsucker damage

Tree #1: Remove when actionable.

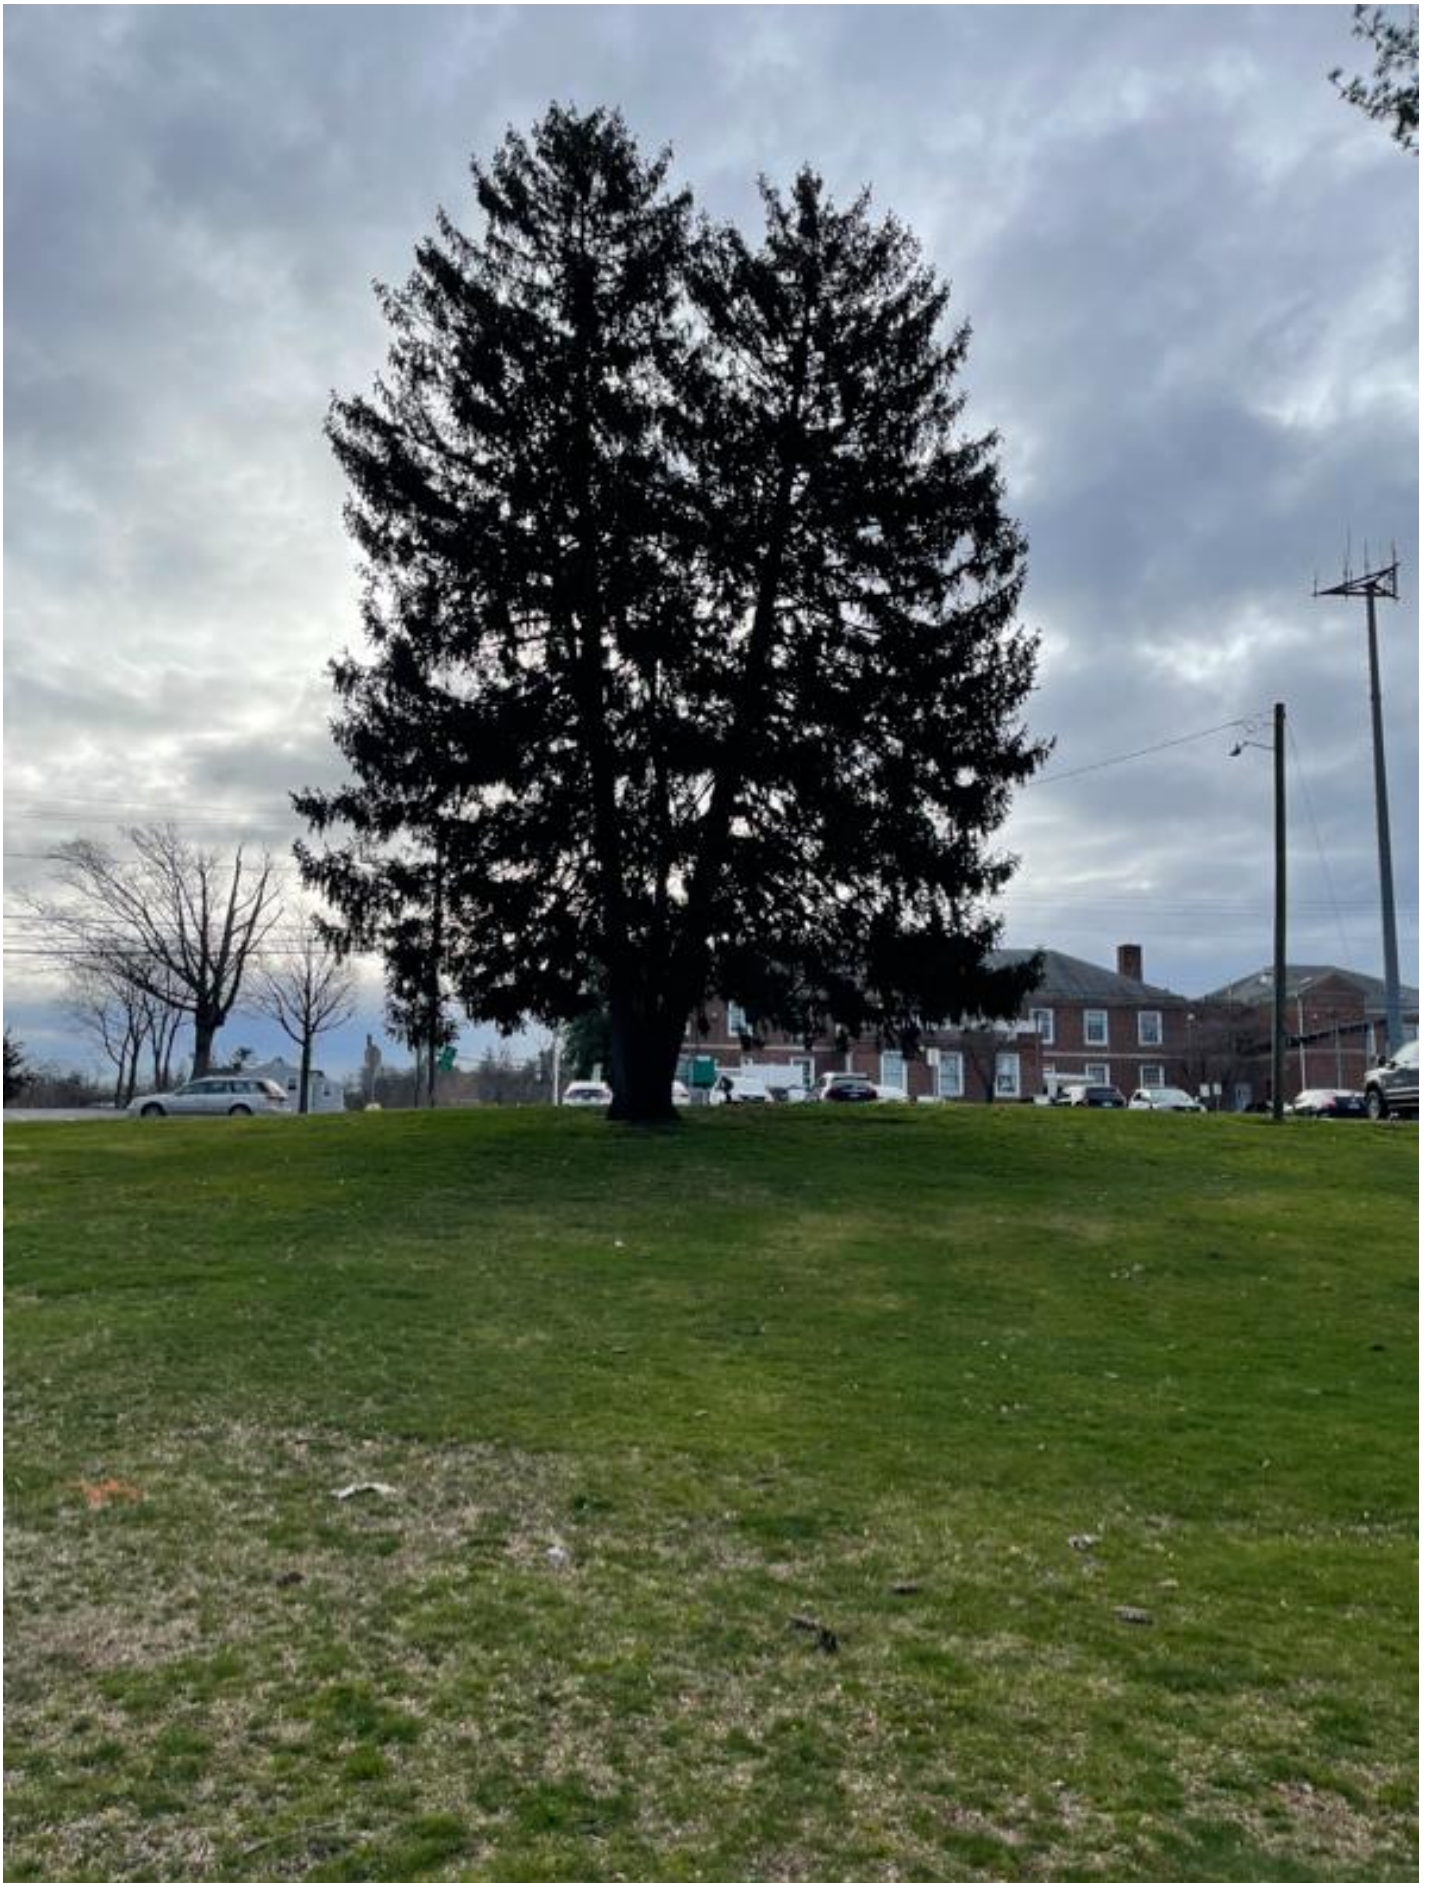
Photograph 2: View of Tree #1 showing trunk and codominant crown structure.

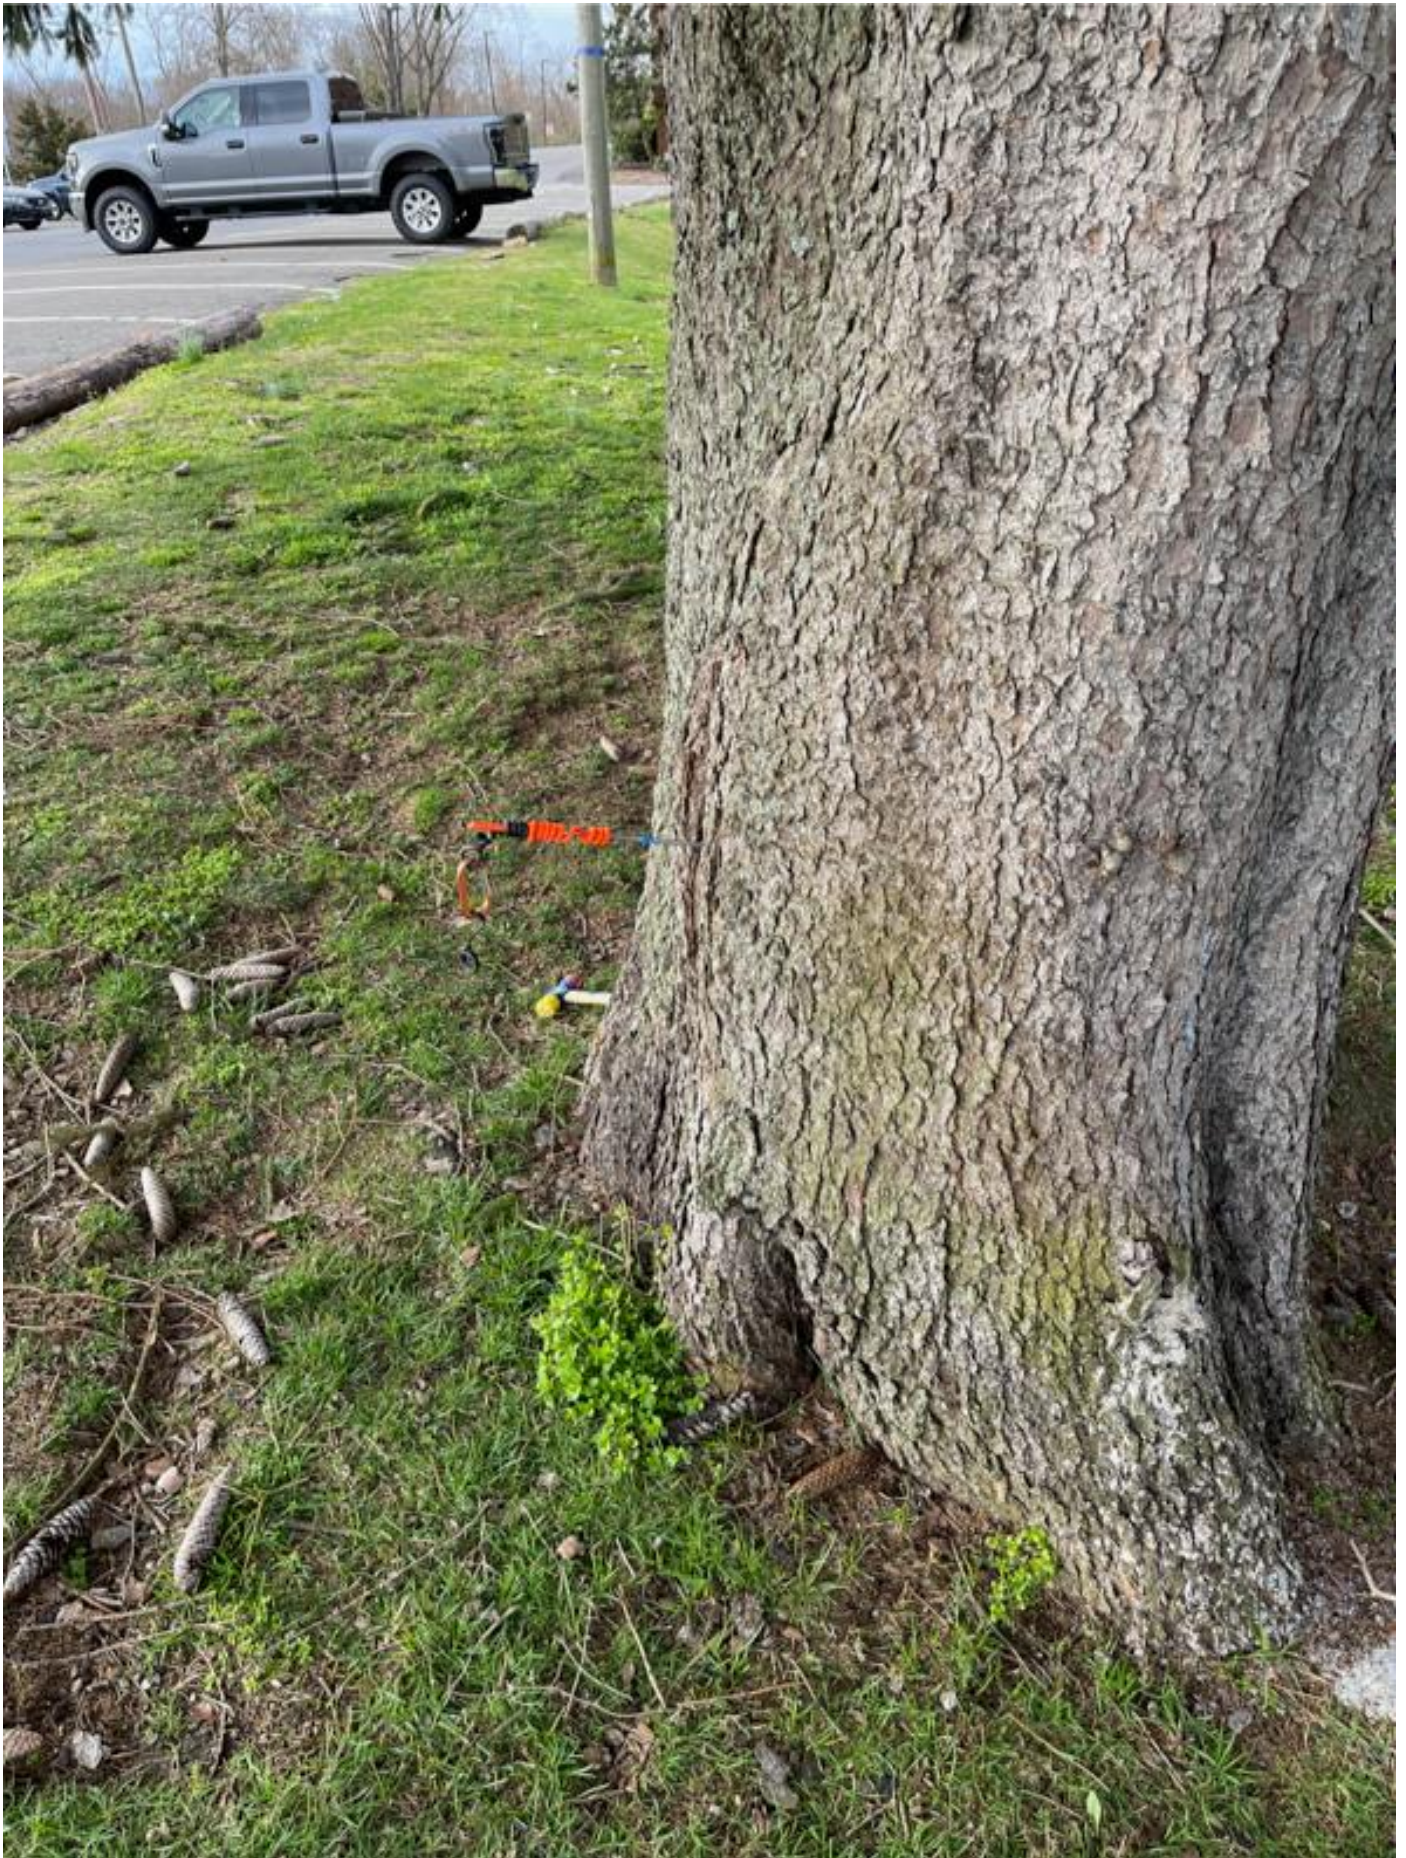
A metal probe with blue and red marking spaces every 3-inches was used to inspect the codominant stems (appendix B Photos 3,4,5). The seam extends from the soil line to where the stems bifurcate approximately 3.5 to 4- feet above grade (appendix B photo 6). When sounded with a mallet the seam as well as portions of the stems indicated hollow sections as well as possible decayed sections. Large surface roots with mechanical damage were also observed (appendix B photo 7).

Photograph 3: Tree #1 probe inserted into seam east side of tree.

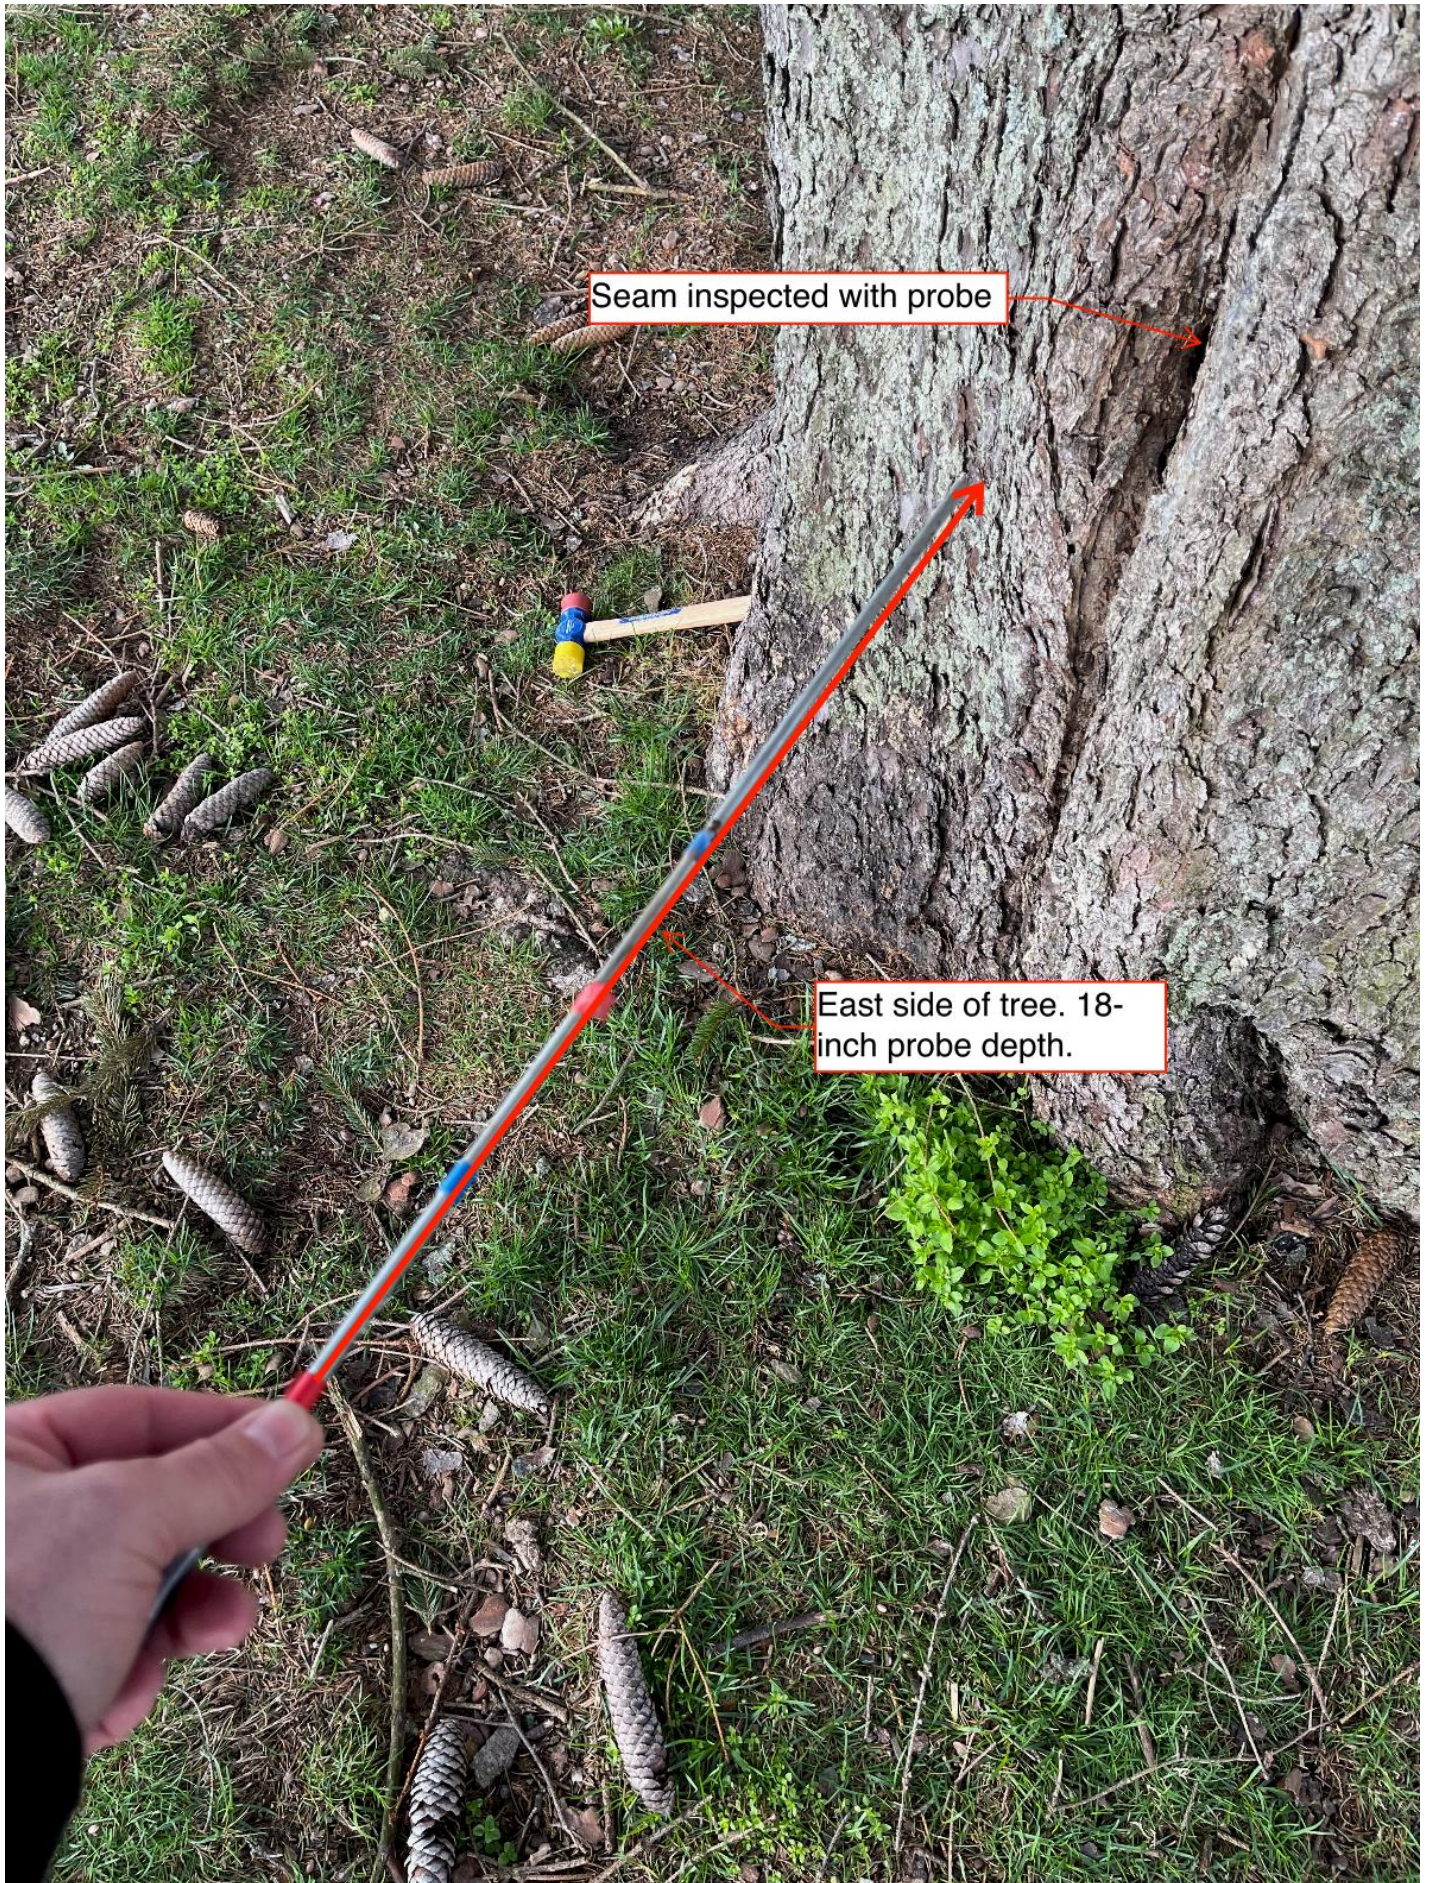
Seam inspected with probe

East side of tree. 18-inch probe depth.

Photograph 4: Tree #1 seam probed to a depth of 18 inches.

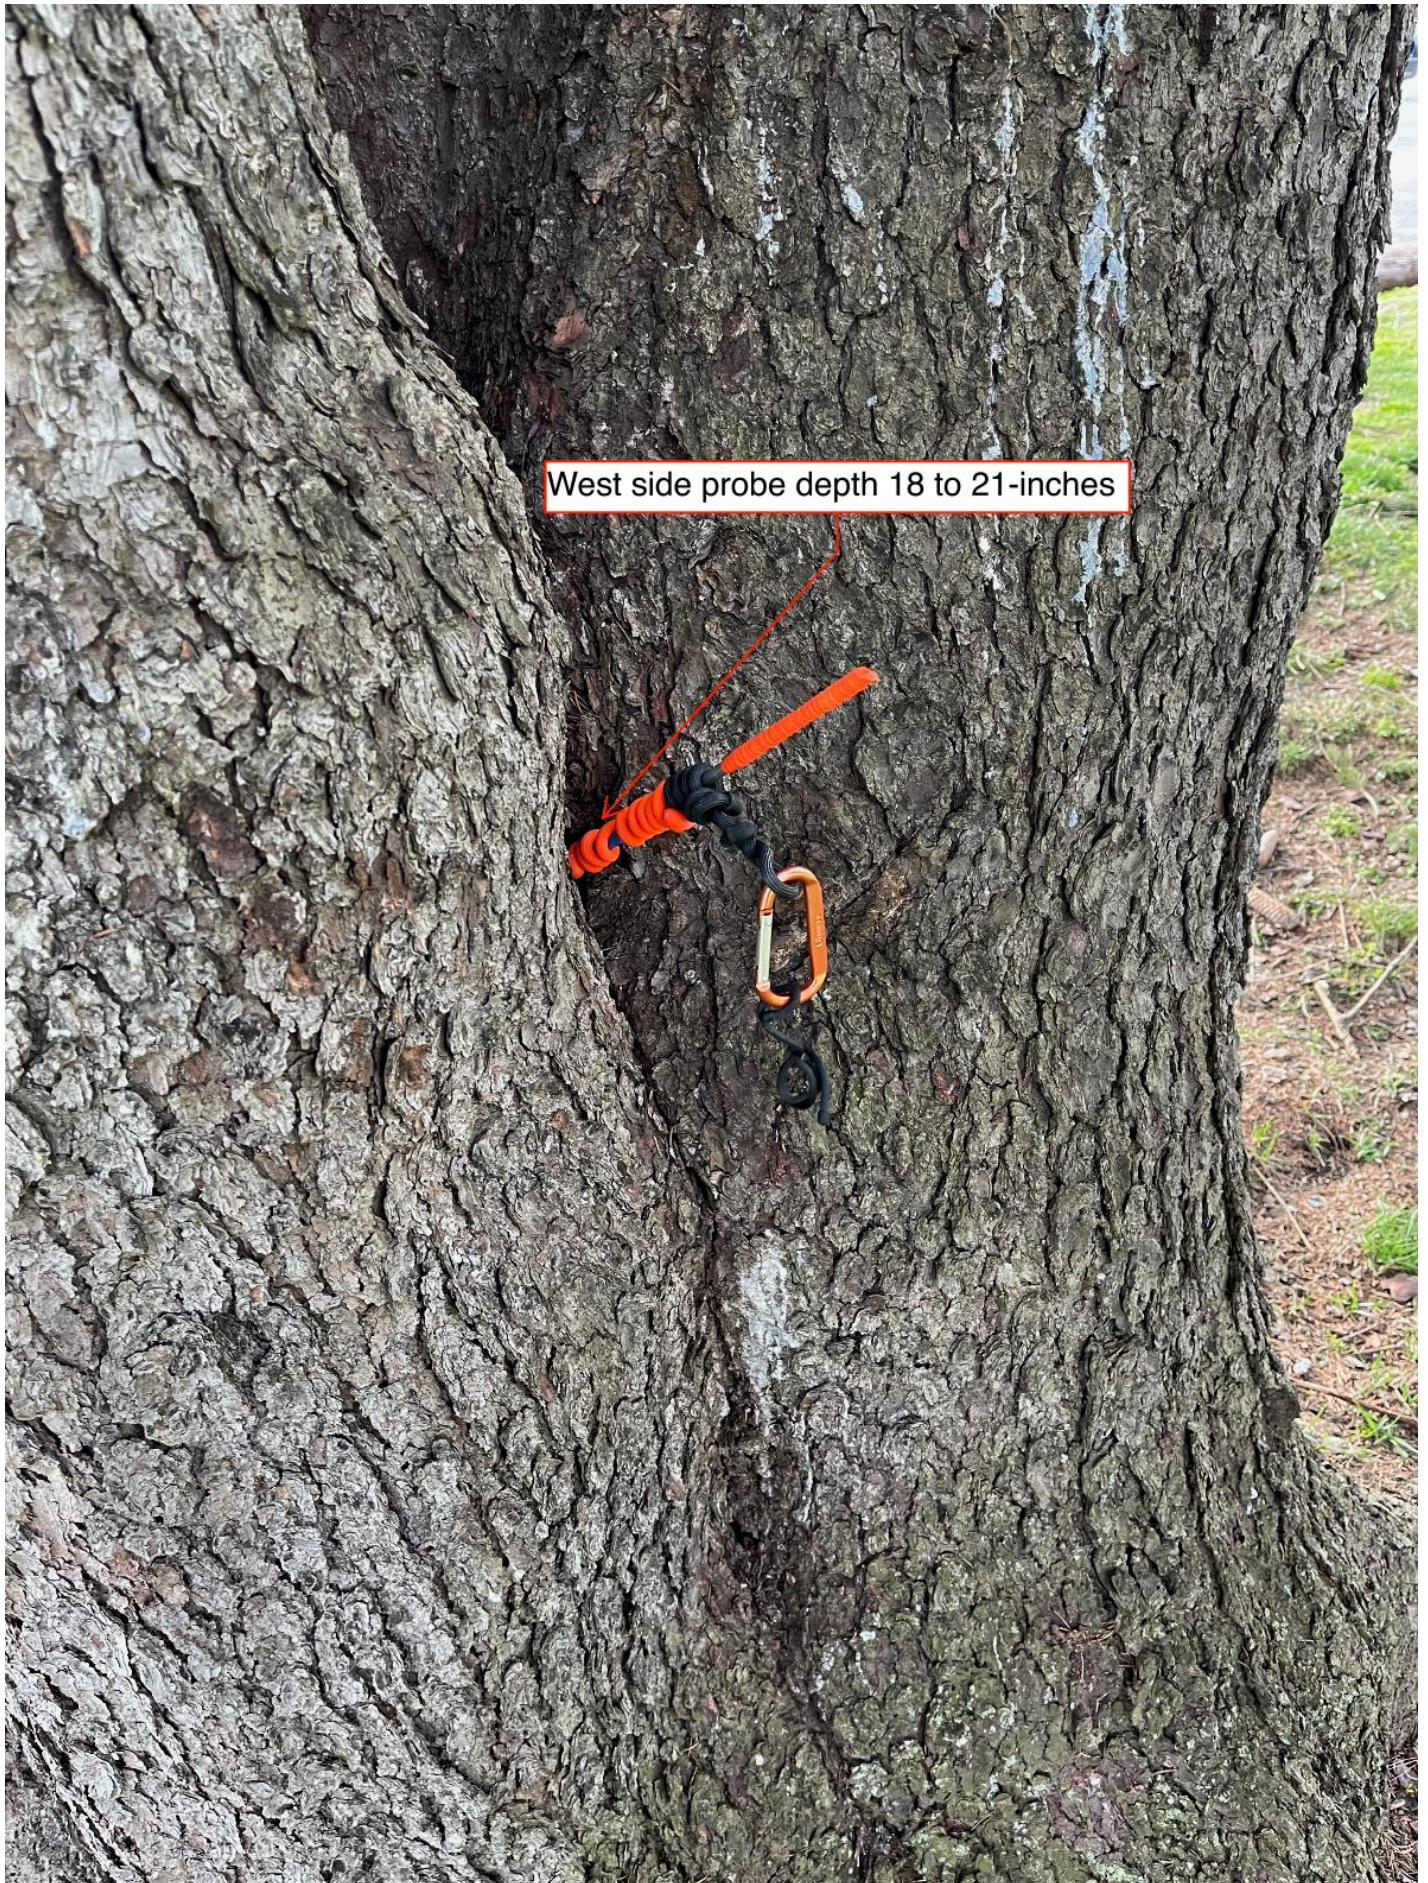
Photograph 5: Tree #1 Probe inserted into seam 18 to 21-inches on west side of tree.

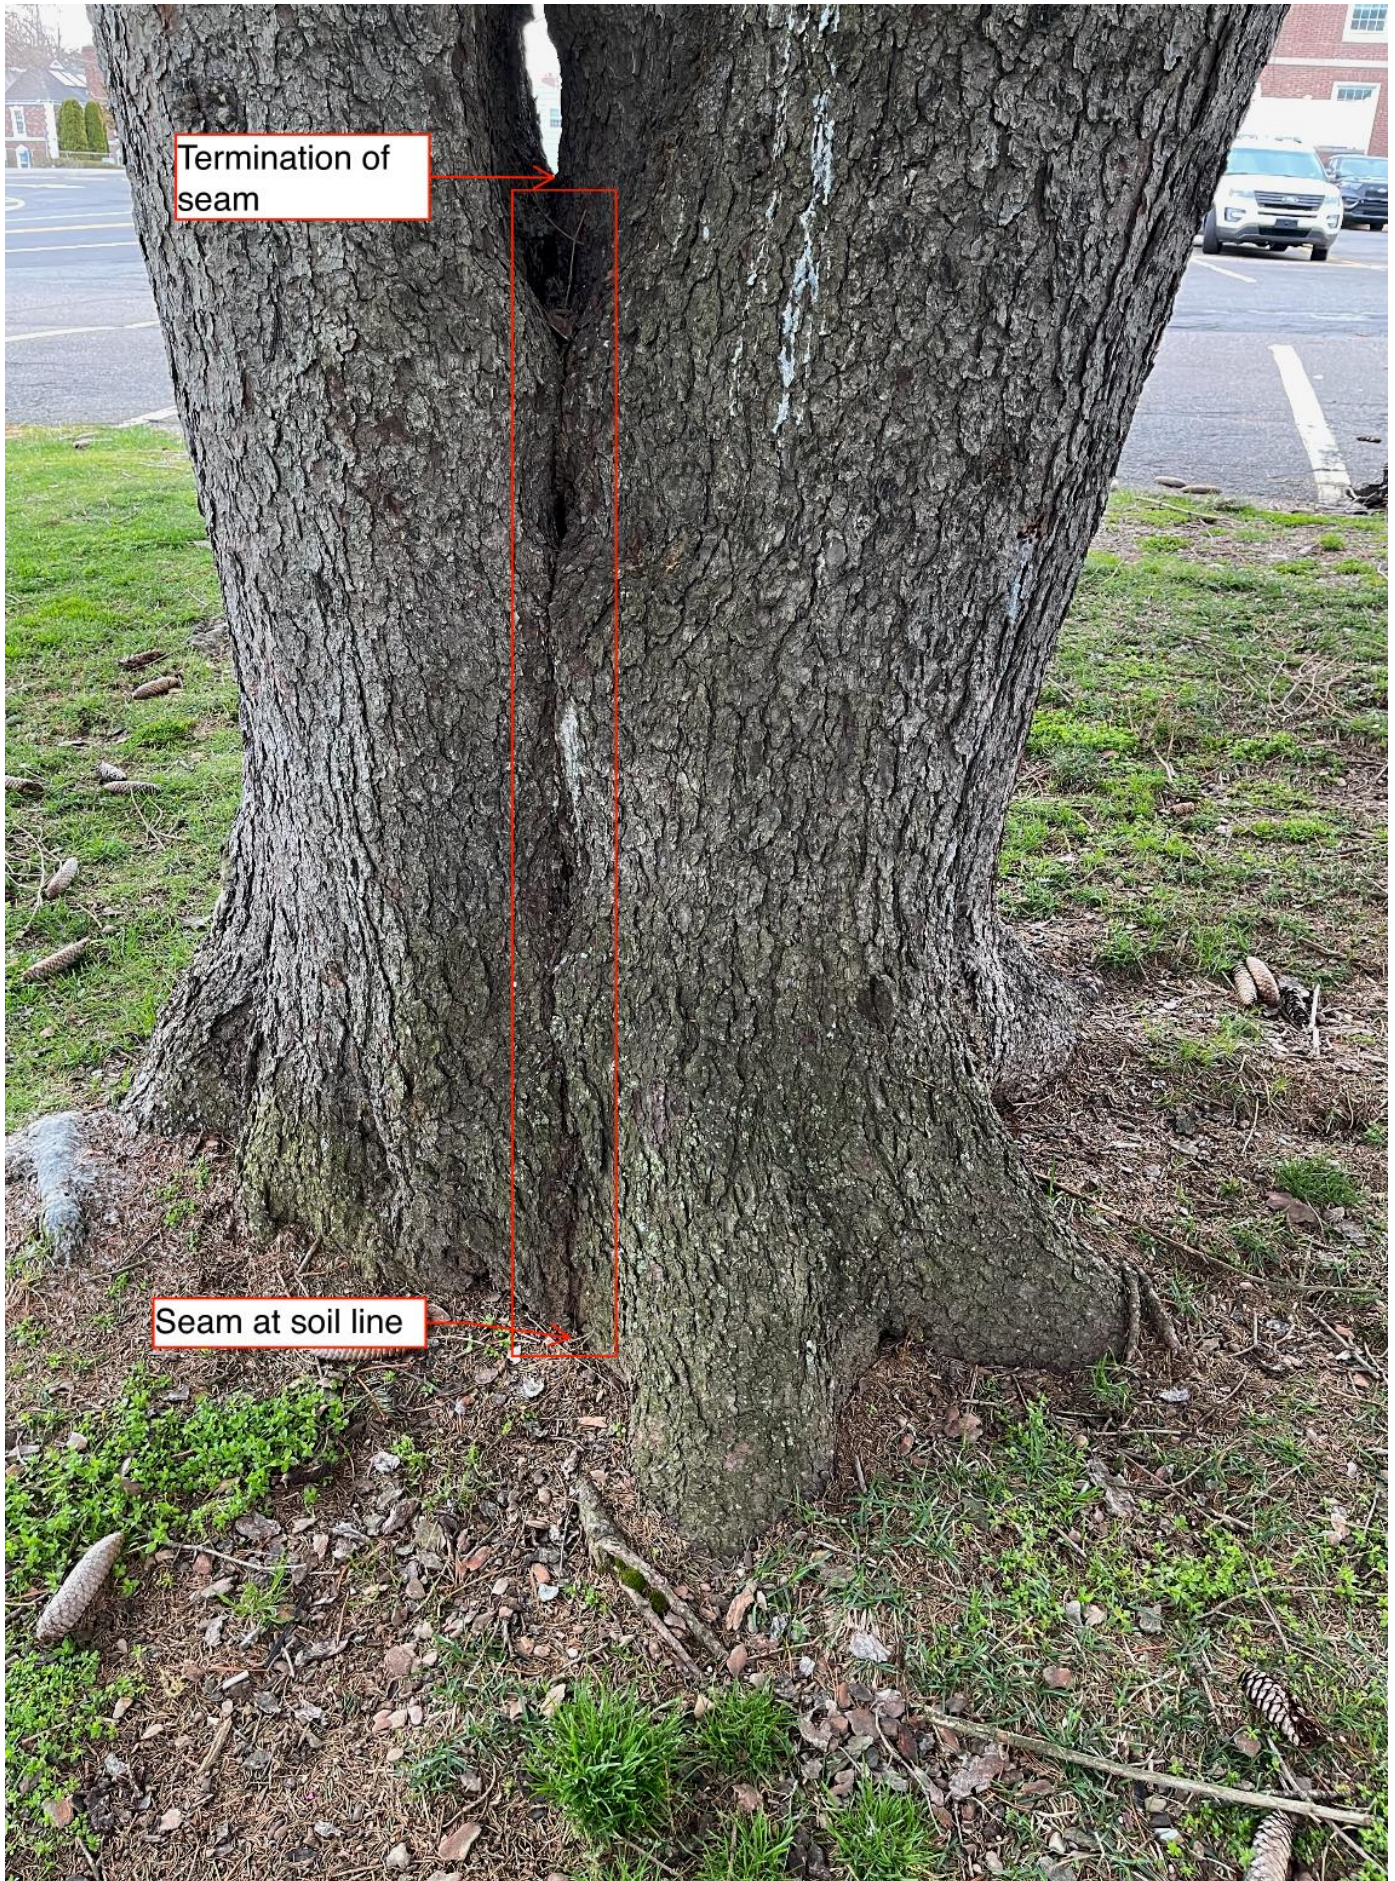
Photograph 6 Tree #1: Seam view from west side of tree.
