Tree Risk Assessment

Town of Westport Public Works
110 Myrtle Ave
Westport, CT 06880

Jesup Green
20 Jesup Rd.
Westport, CT 06880

April 8, 2024

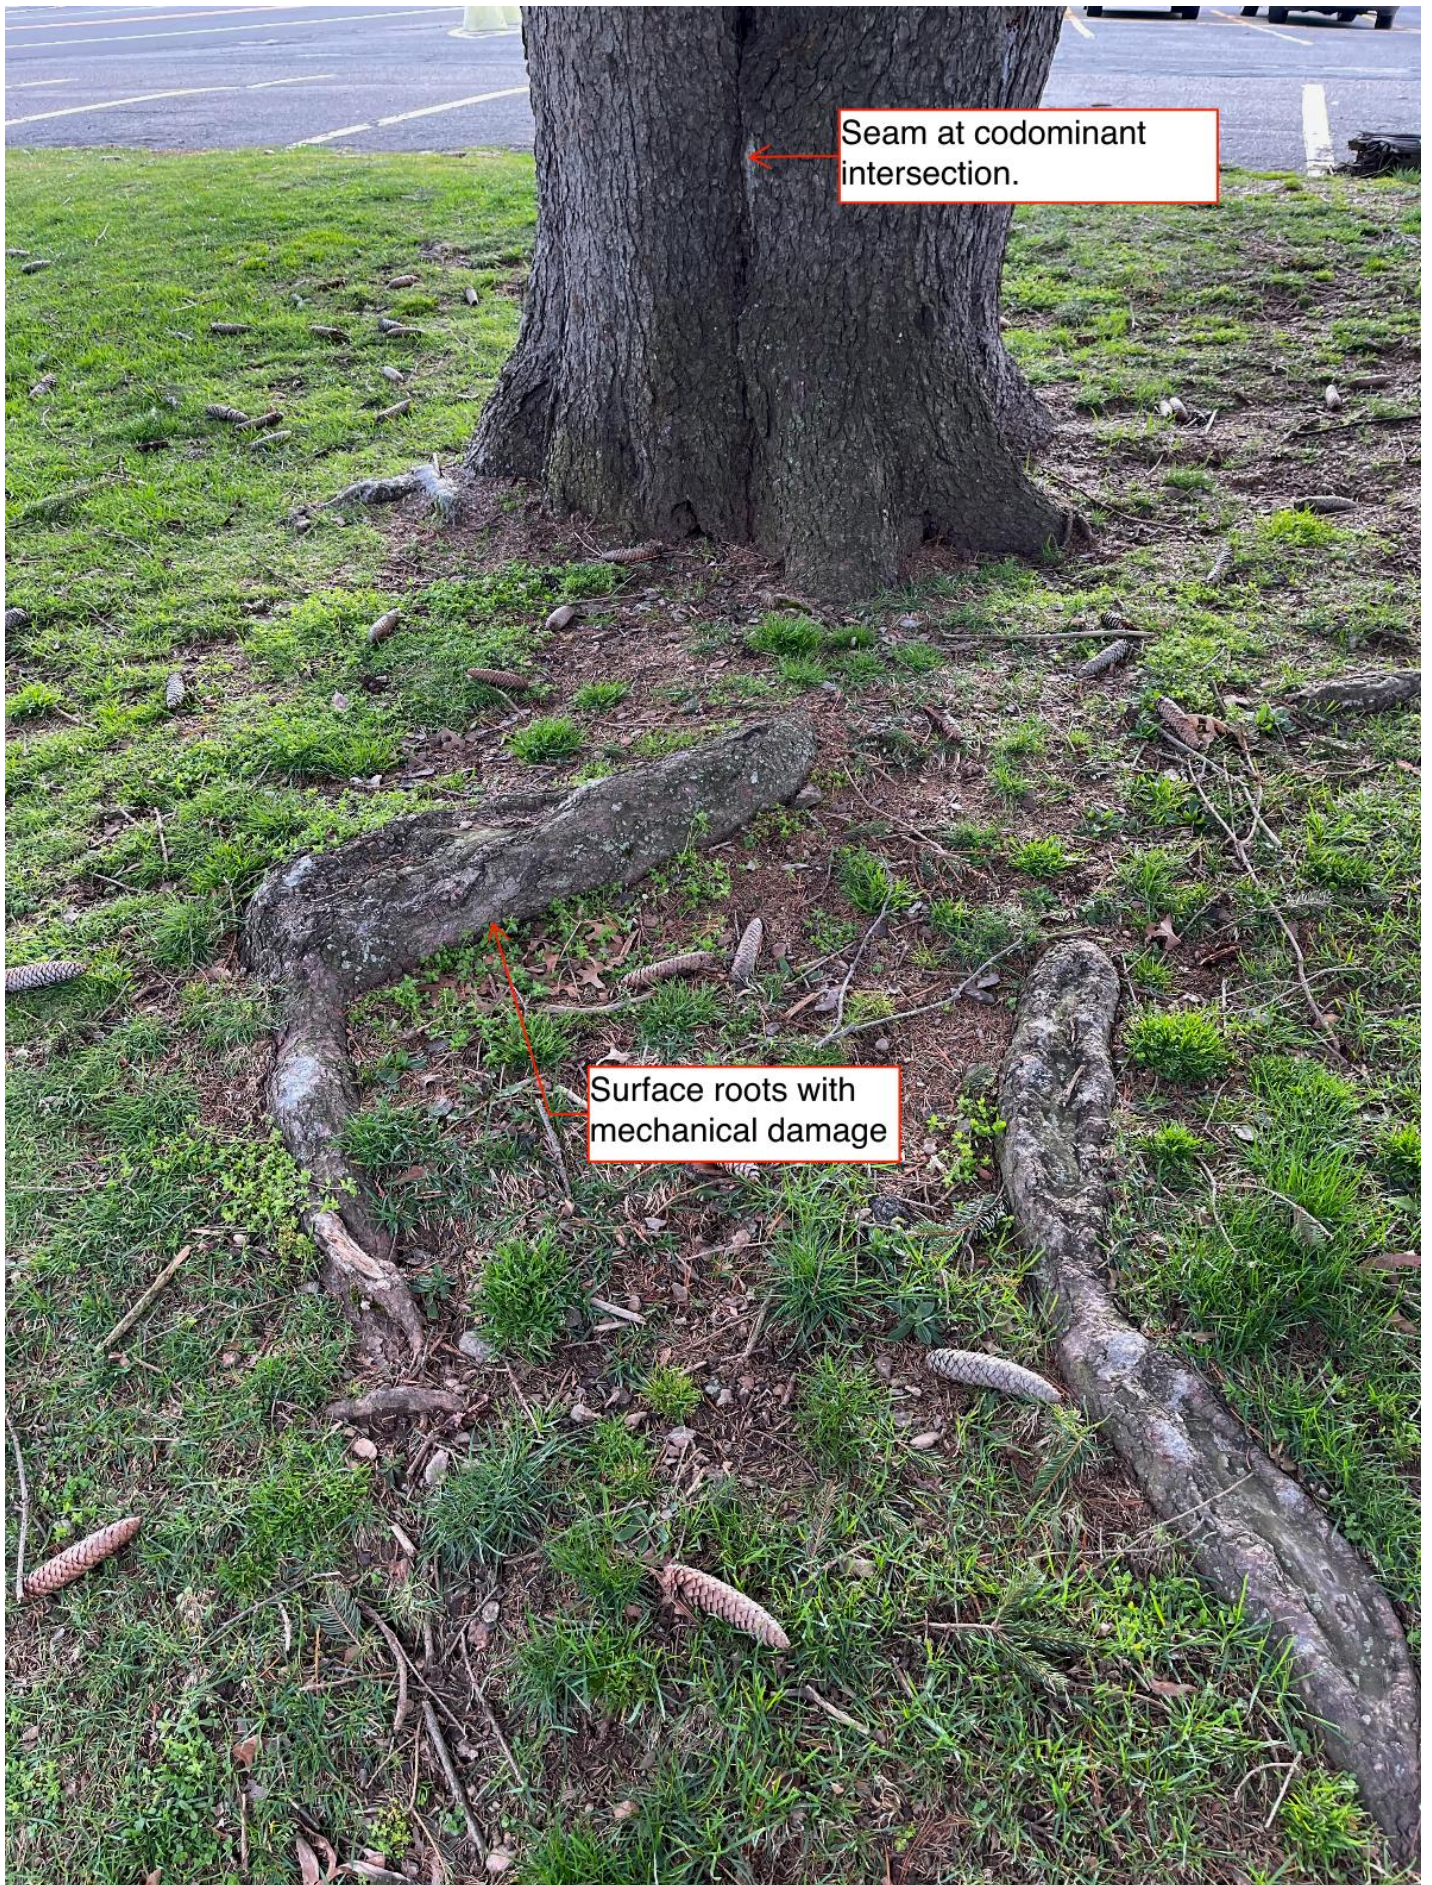
A metal probe with blue and red marking spaces every 3-inches was used to inspect the codominant stems (appendix B Photos 3,4,5). The seam extends from the soil line to where the stems bifurcate approximately 3.5 to 4- feet above grade (appendix B photo 6). When sounded with a mallet the seam as well as portions of the stems indicated hollow sections as well as possible decayed sections. Large surface roots with mechanical damage were also observed (appendix B photo 7).

Potograph #7: Tree #1 Surface roots with mechanical damage west side of tree.

Tree #1: Remove when actionable.

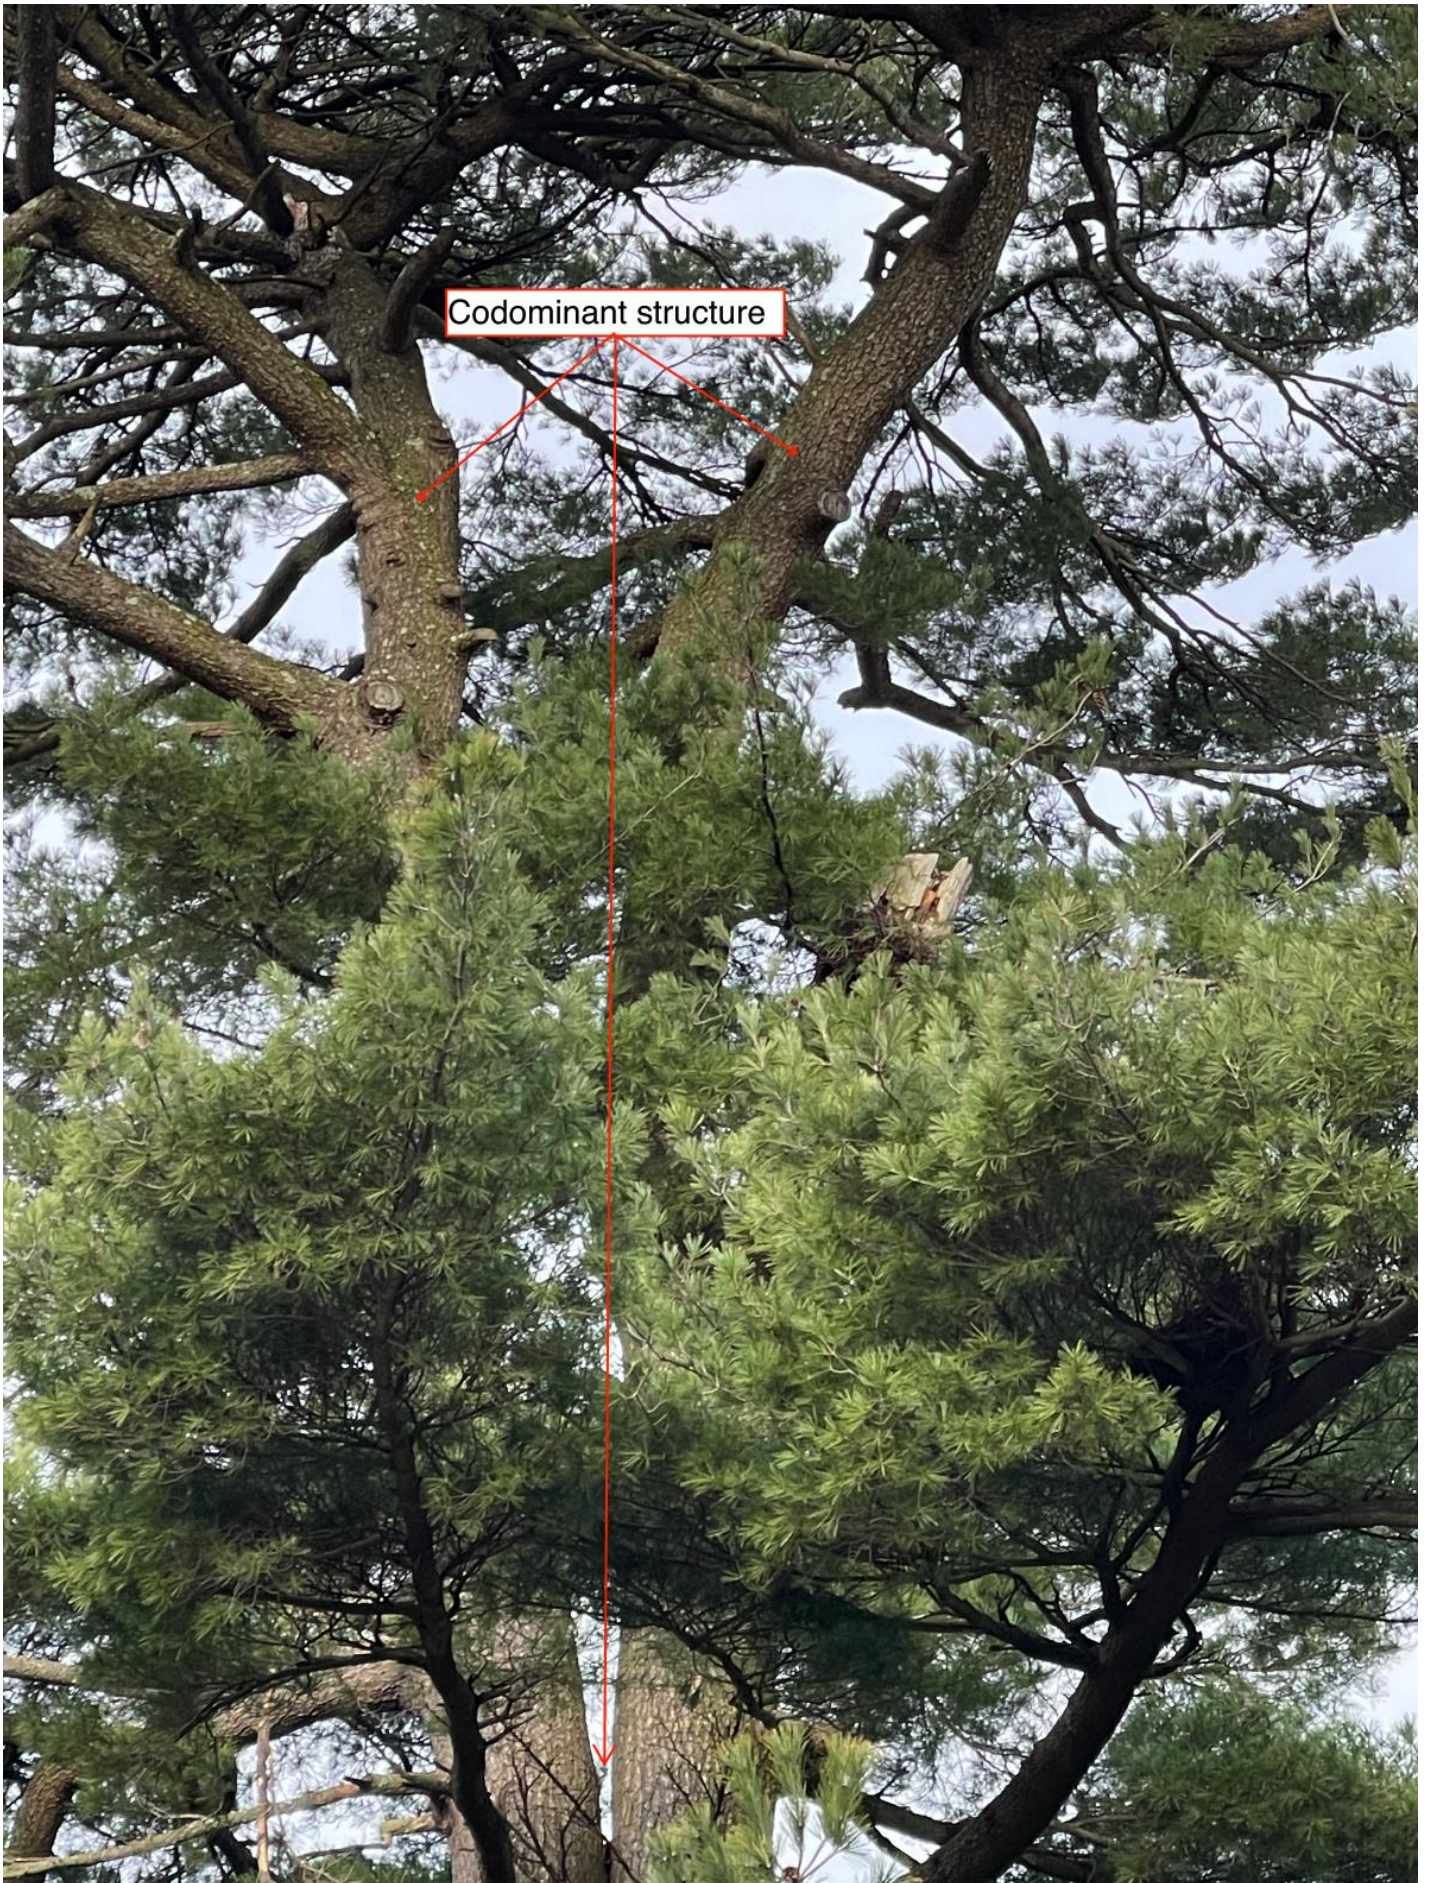
The White Pine is located in the southeastern portion of the Green adjacent to the library. The tree is approximately 95-foot tall and 52-inch DBH with codominant structure with **included bark** likely (appendix B photos 8 and 9). The codominant intersection begins approximately 44-feet from grade level. The tree has an 8 to 12-degree lean towards the southwest. The trees canopy presents with over extended branches outside the natural canopy shape. A previous large diameter branch failure can be identified in the upper third of the tree on the north side (appendix B photos 10 and 11). Discoloration of the stem at the base of the codominant intersection resembling wet bark was observed (appendix B photo 12). Several branches in the lower portion of the canopy show weak attachment with sharp angles or more than one branch growing from a single point of origin.

Potograph #8: Tree #2 Codominant structure.

Tree #2: Perform a level 3 investigation to inspect cavity. Wood resistance drilling and or sonic tomography is also recommended for the stem and root crown.

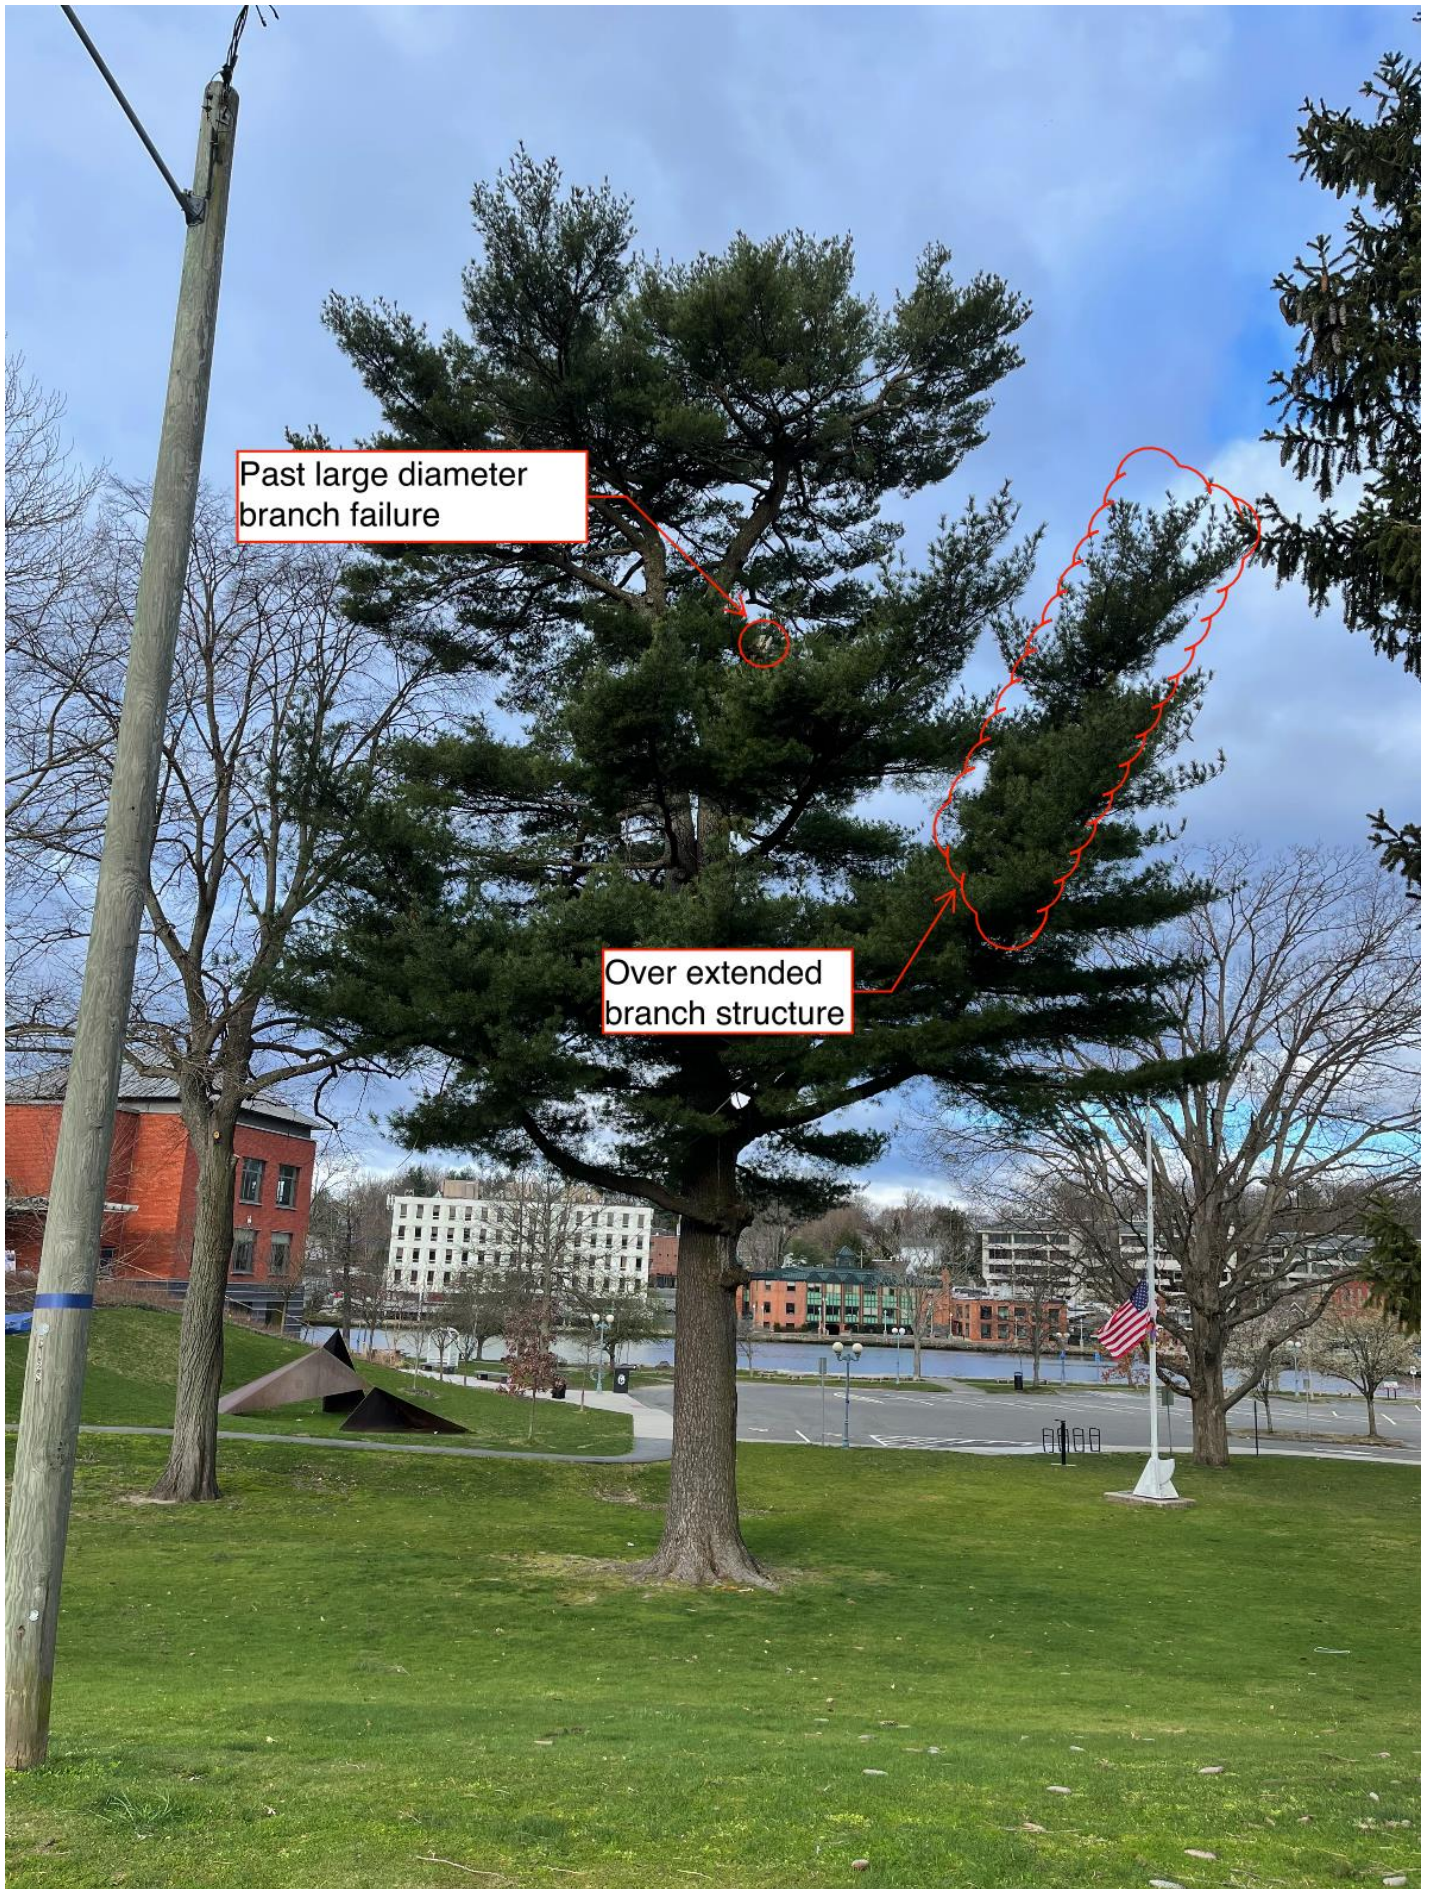
Past large diameter
branch failure

Over extended
branch structure

Potograph #9: Tree #2 Past large branch failure, overextended branch structure.

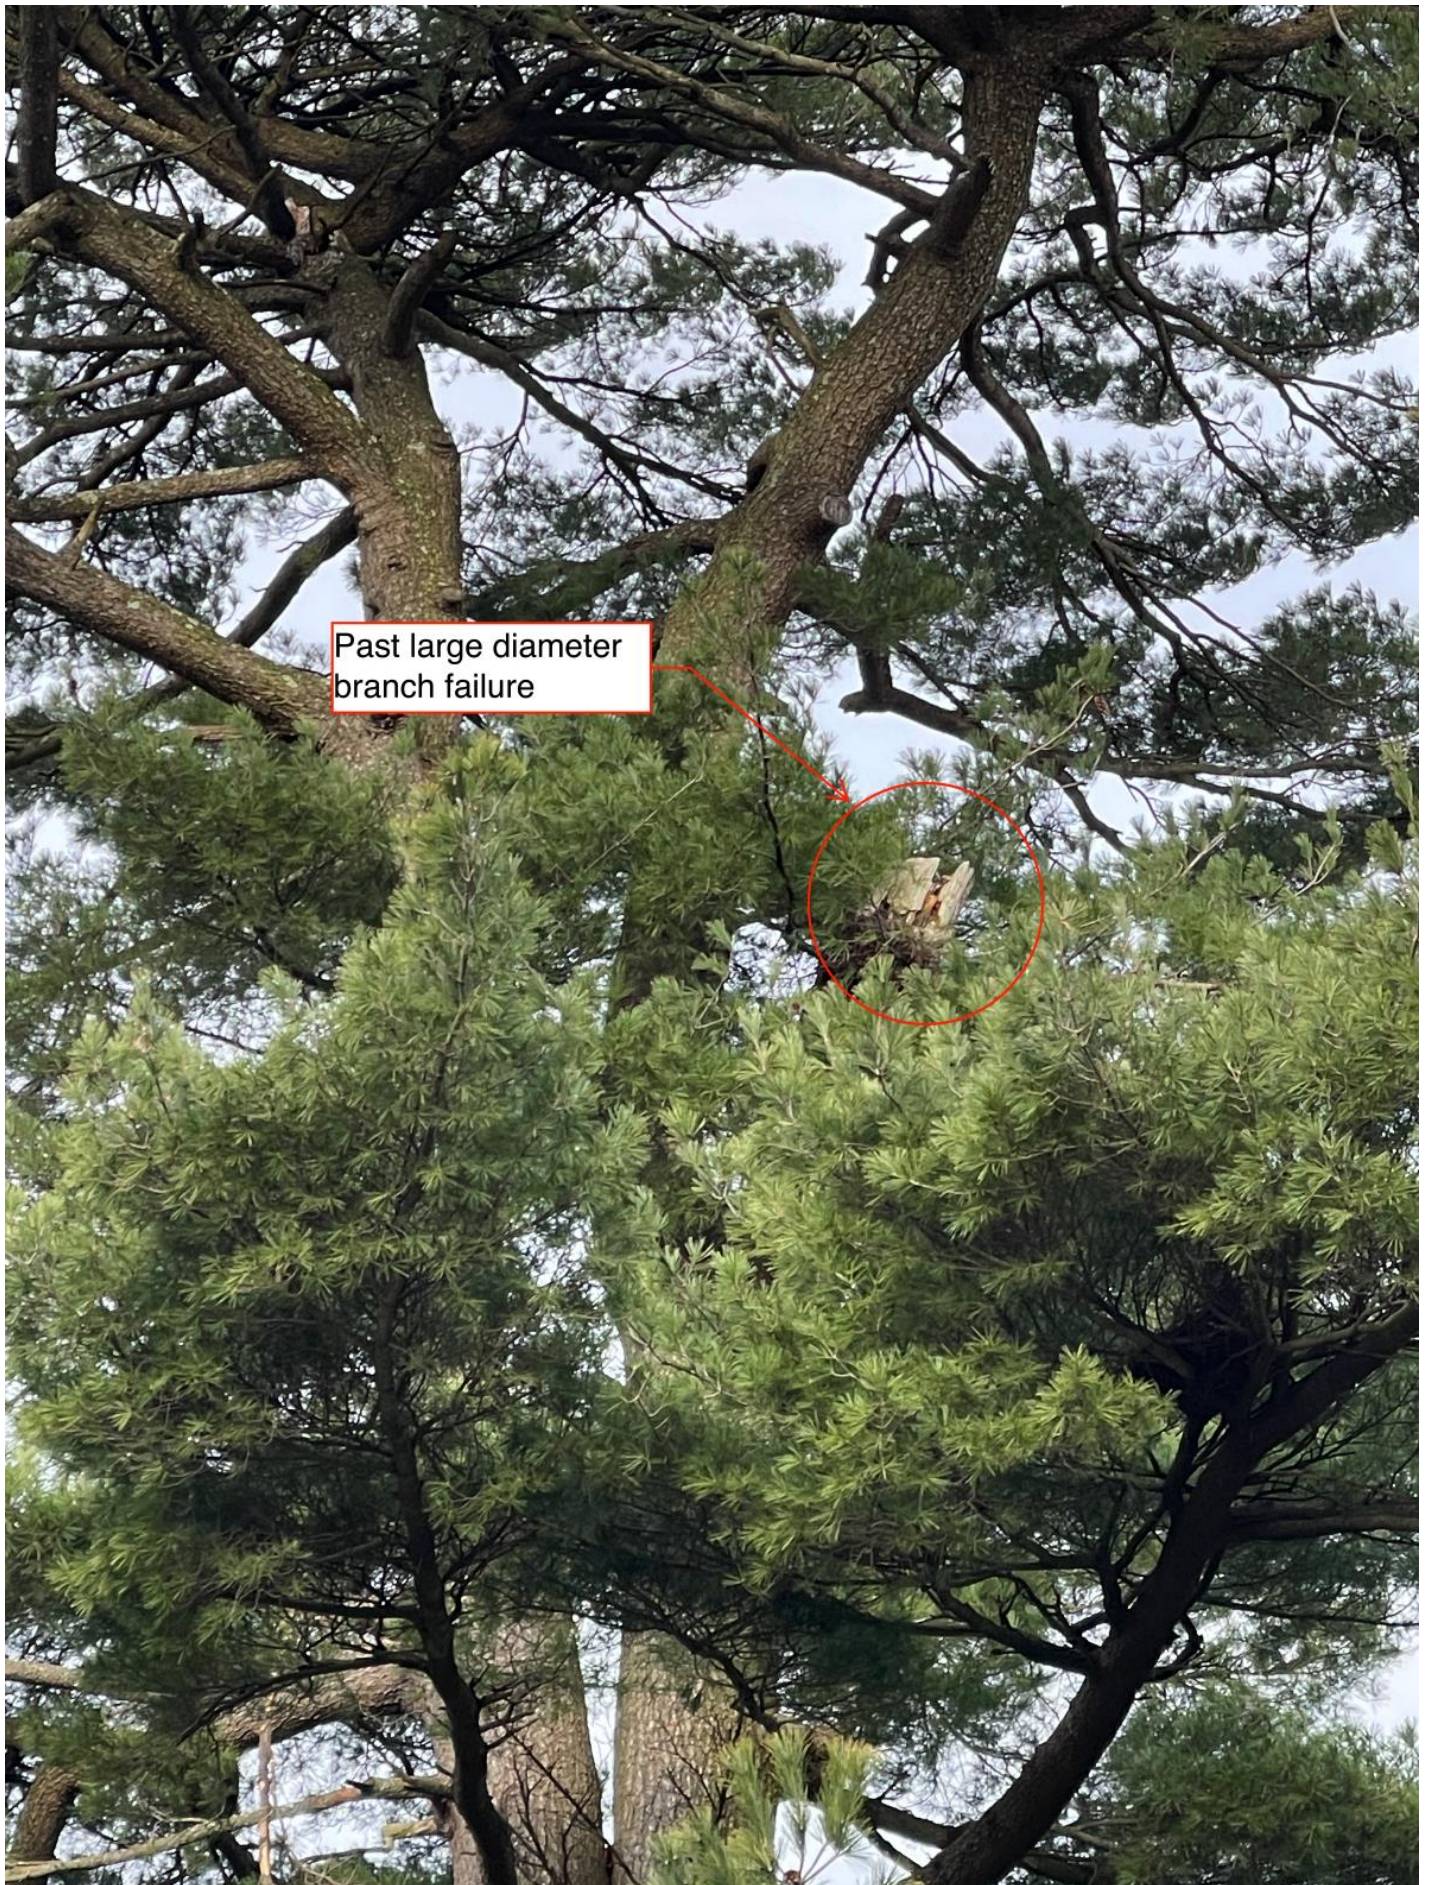
Potograph #10: Tree #2 Closeup of branch failure.

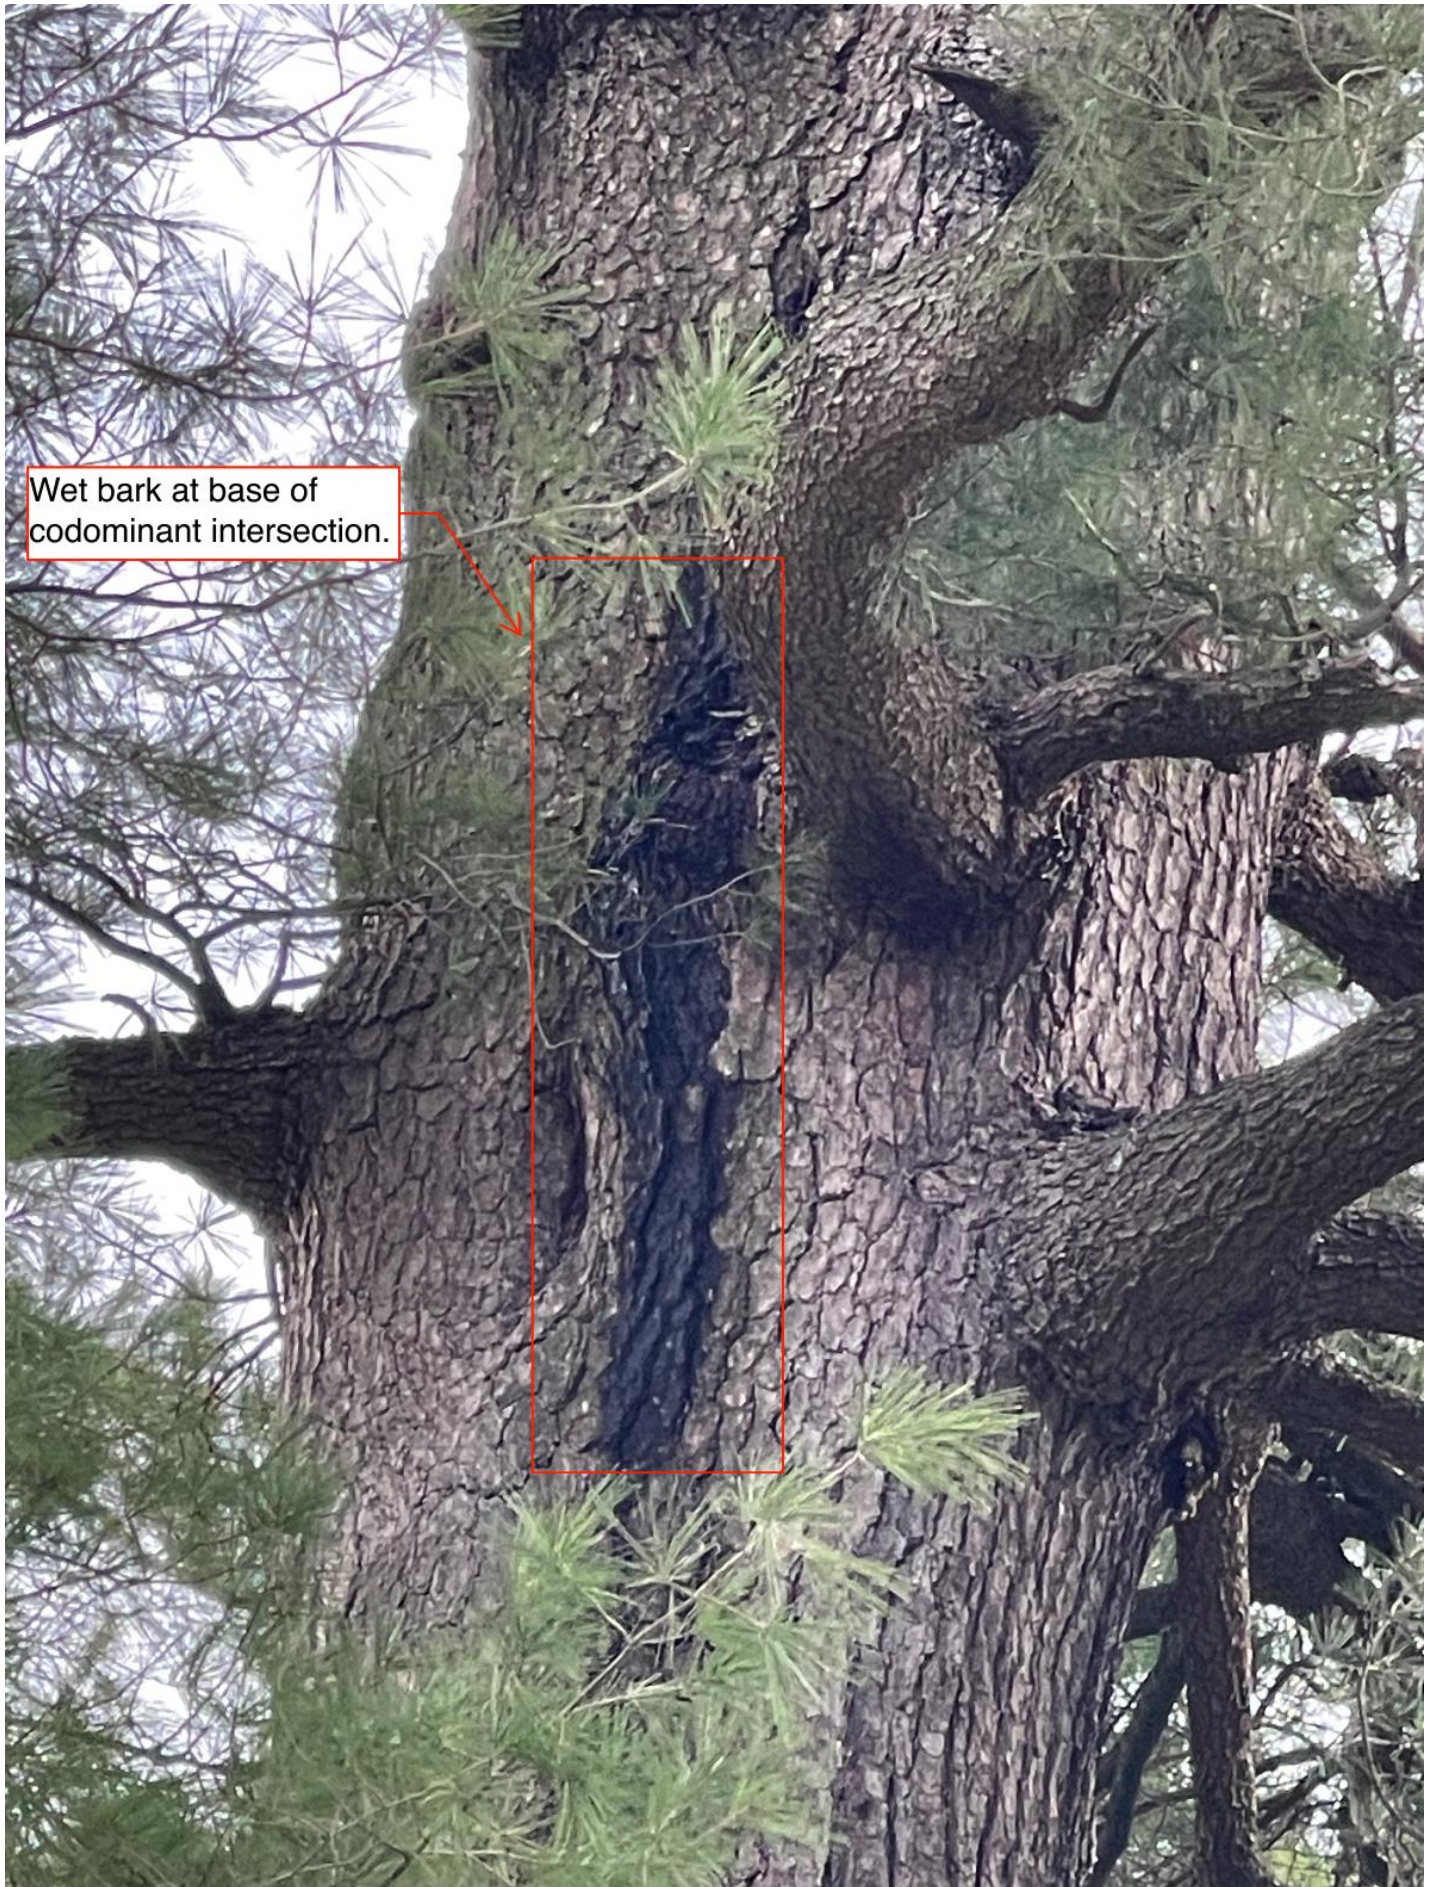
Potograph #11: Tree #2 Wet bark at base of codominant intersection.

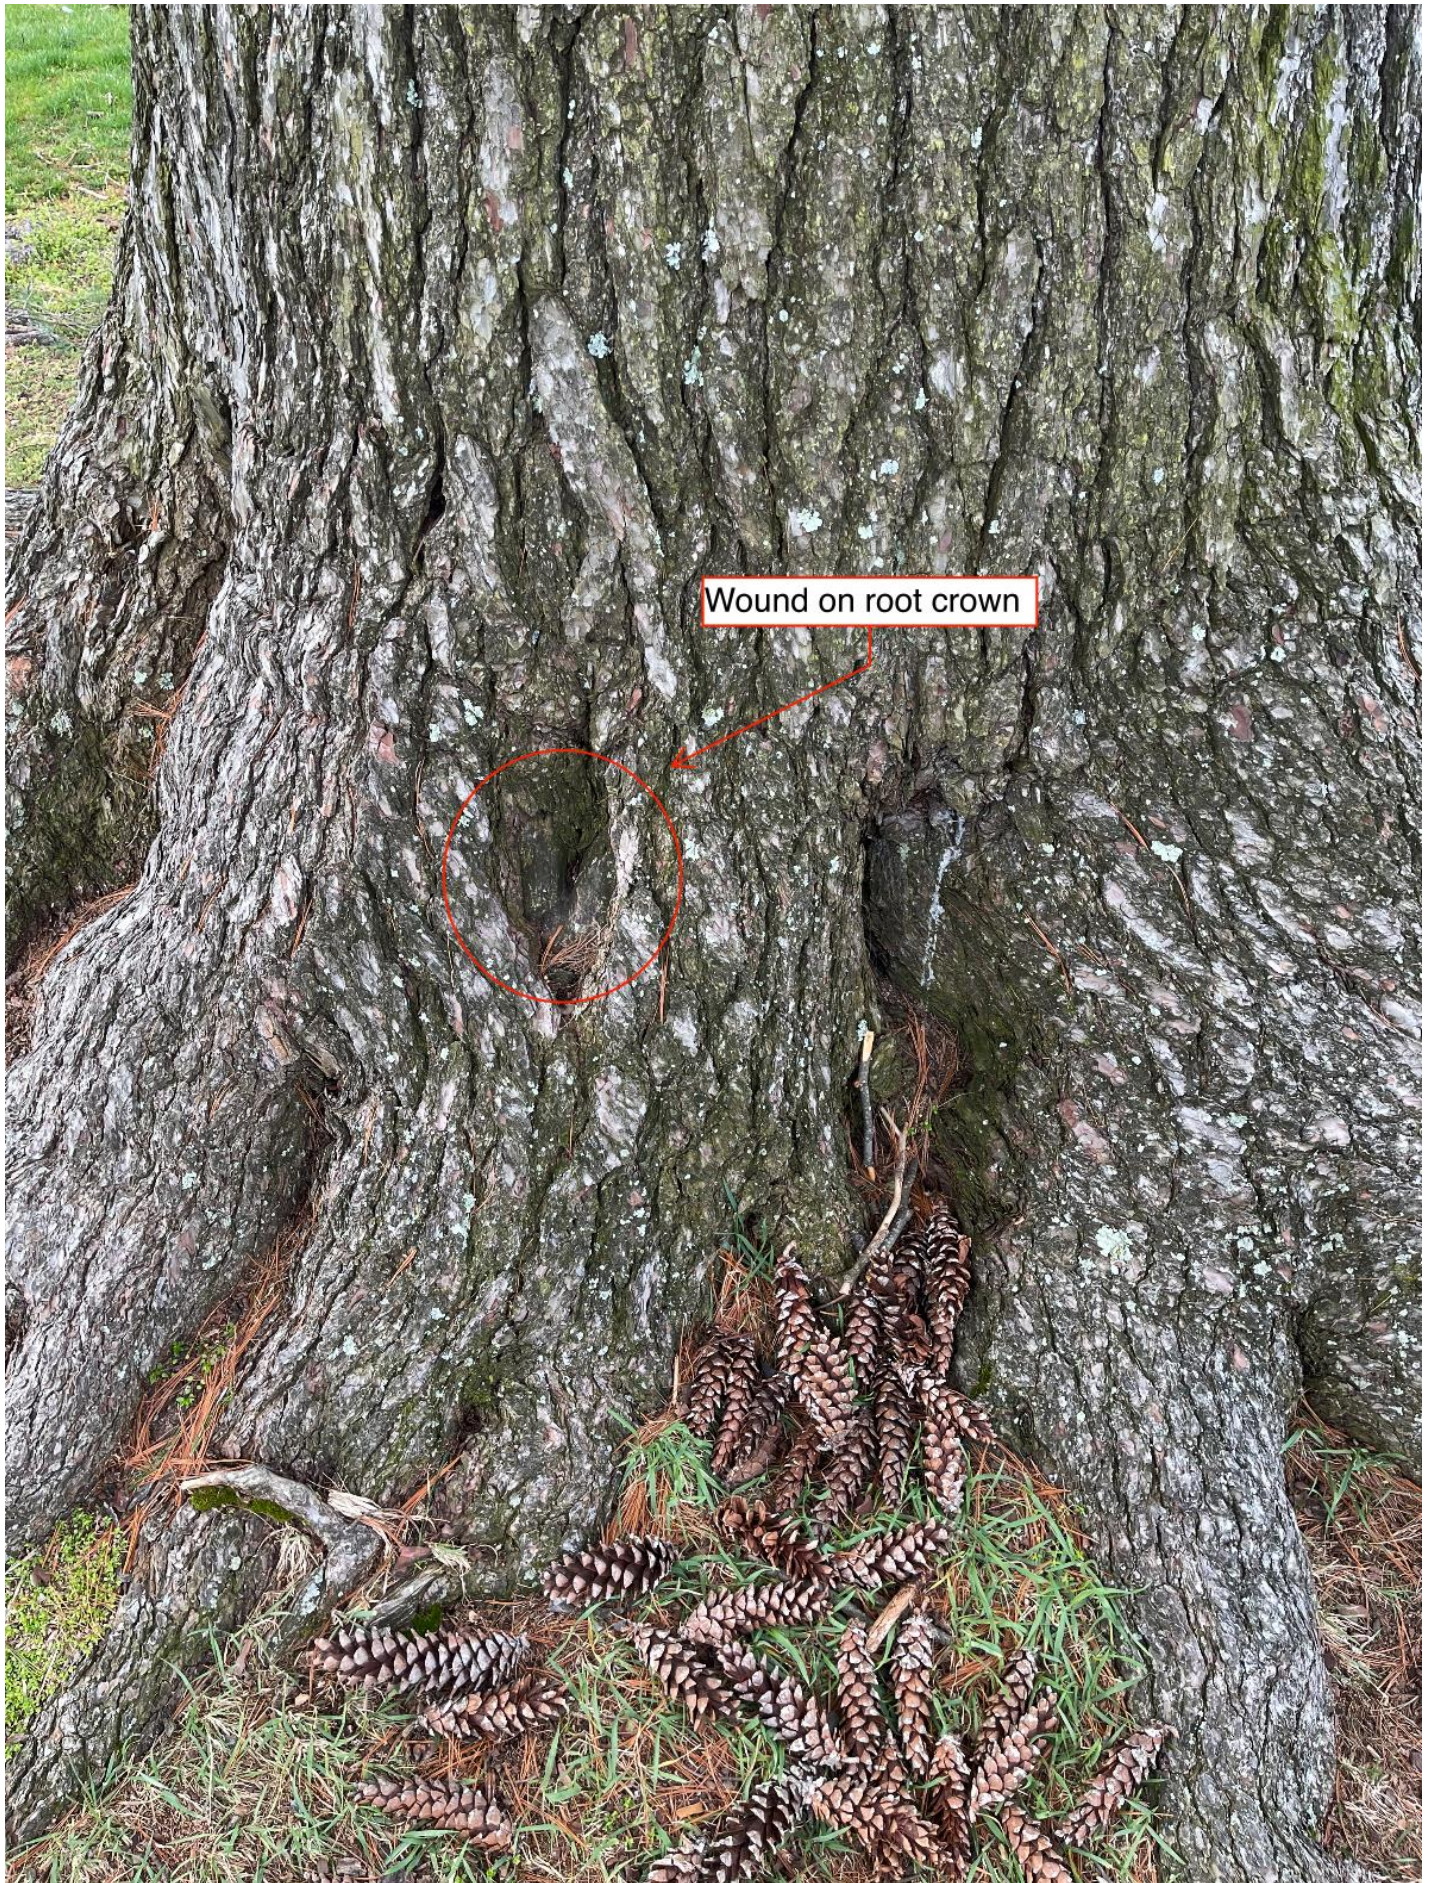
When sounding the lower stem changes in pitch were observed which may indicate inconsistencies in wood density. The root crown as well as surface roots show signs of wounding from mechanical damage (appendix B photos 13, 14, 15) Typical amounts of dead and stubbed branches were observed and is consistent for the species. The tree appears to be in good health though old for the species in the local area.

Potograph #12: Tree #2 Wounding on root crown.

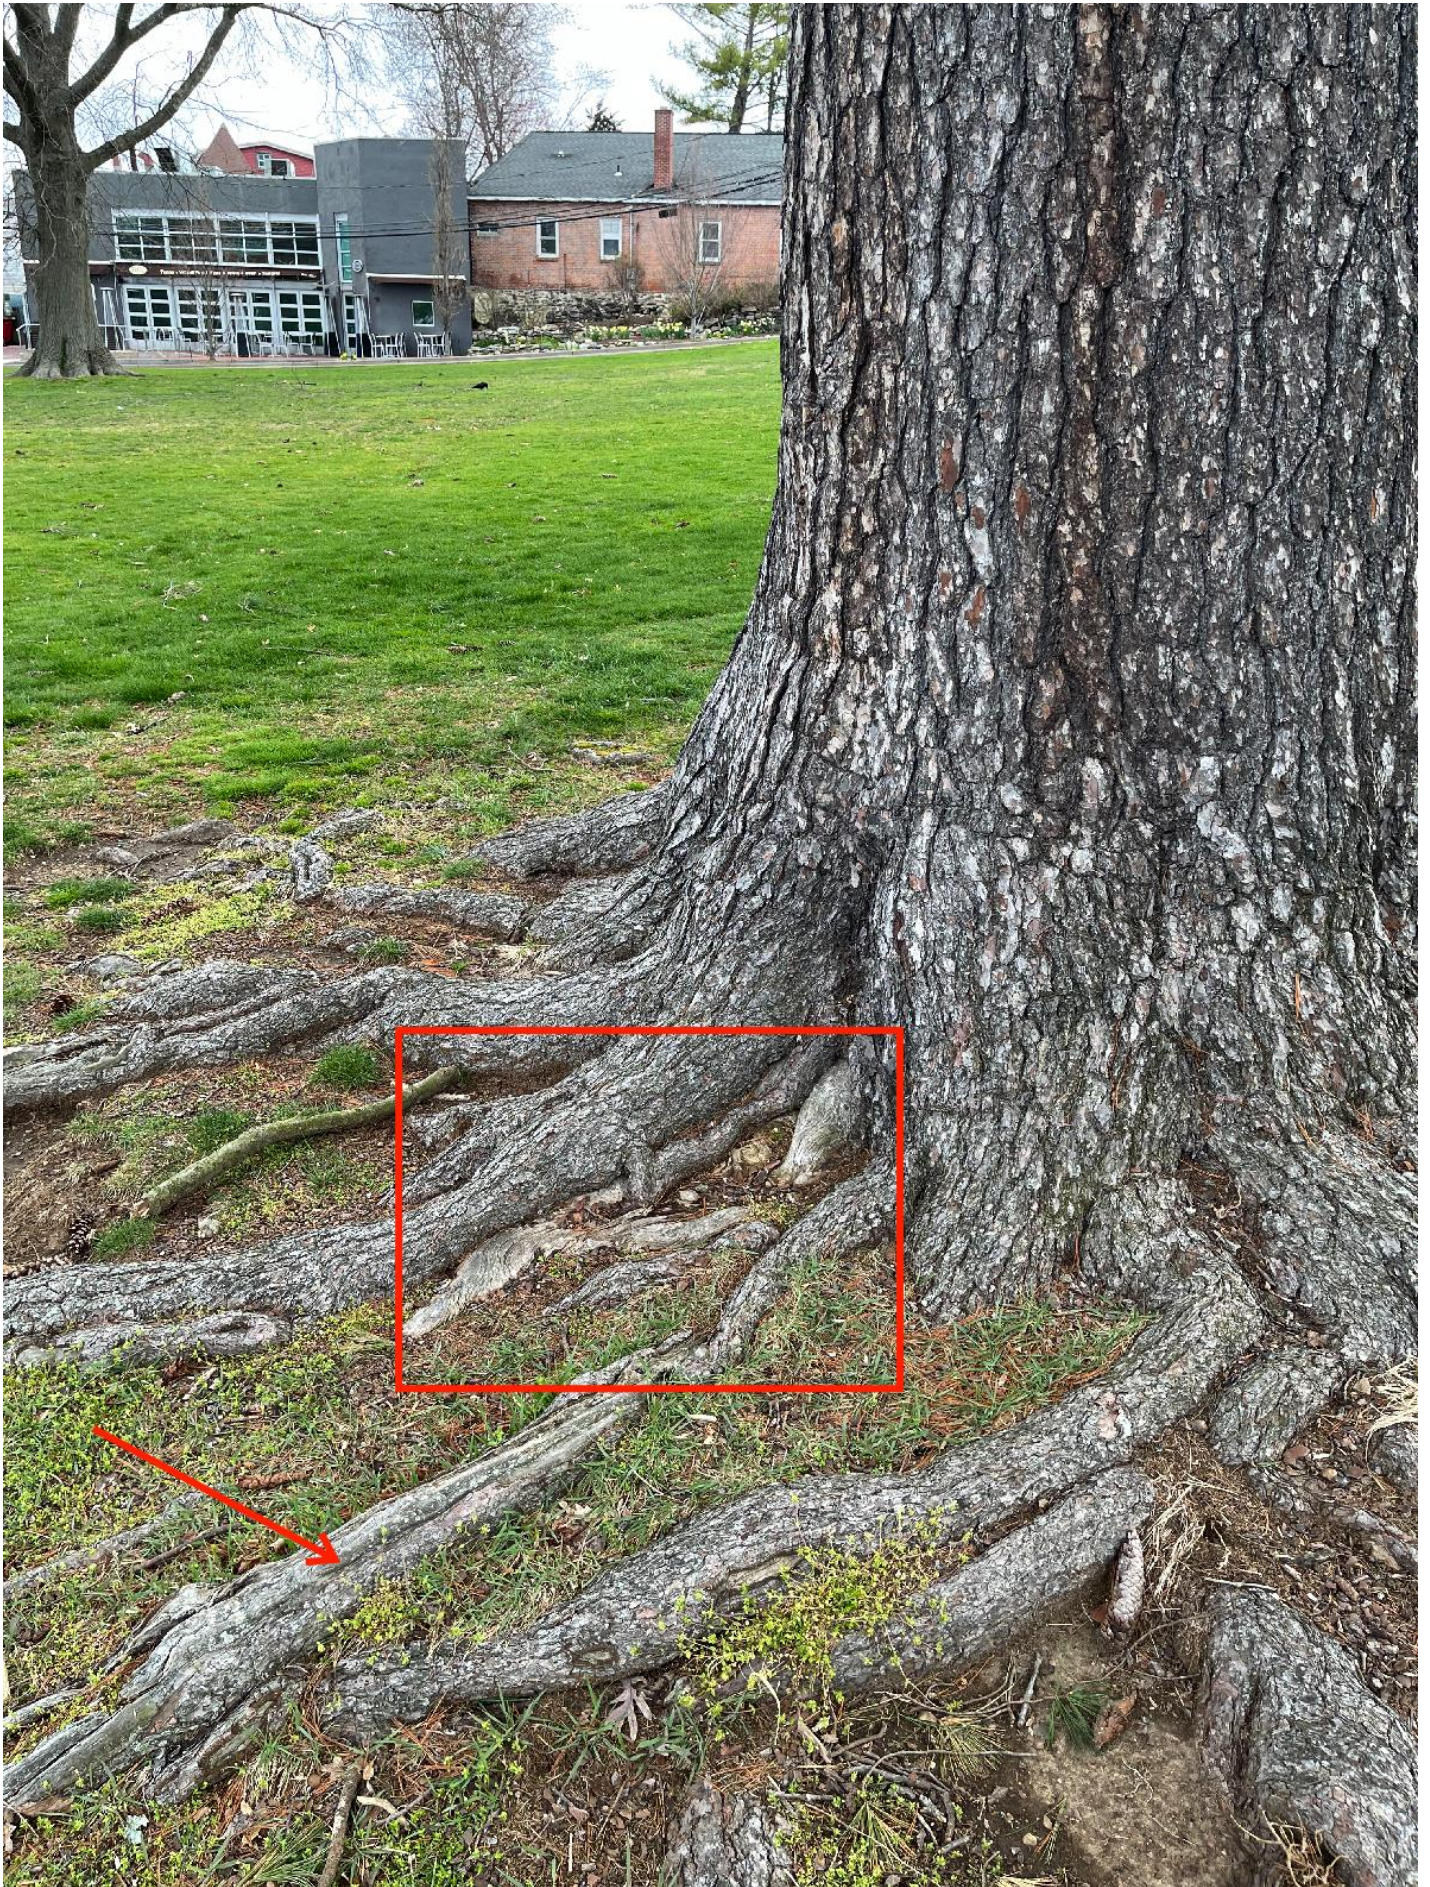
Potograph #13: Tree #2 Surface roots with mechanical damage.

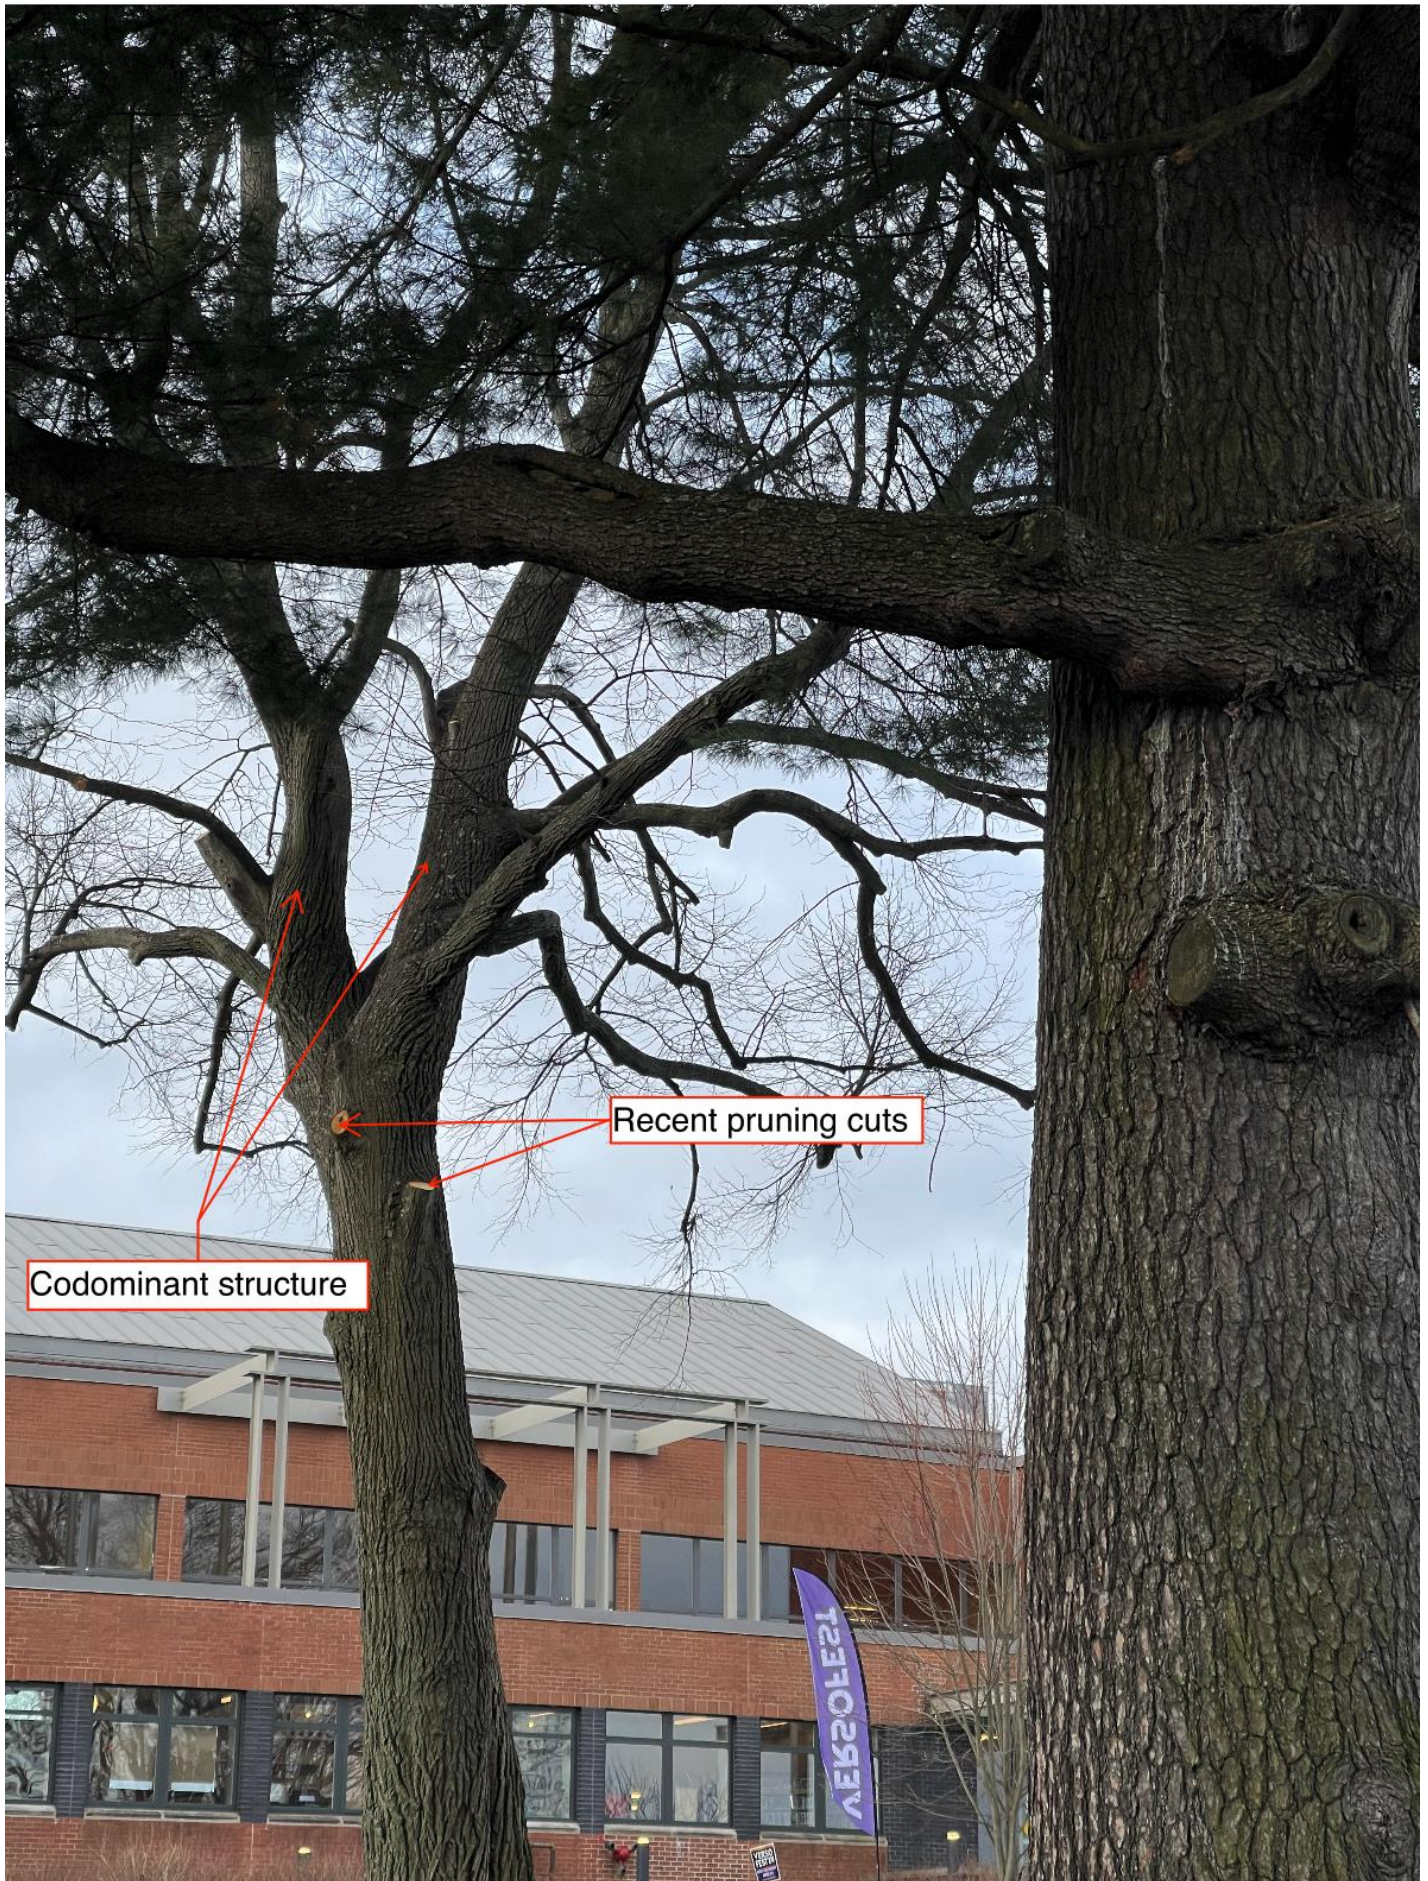
The Linden tree is located south of tree #2 and adjacent to the library. It measures approximately 85-feet tall and has a 38-inch DBH. The tree also has codominant structure and has been recently pruned (appendix B photos 16 and 17). The tree leans to the west 3 to 8 degrees. A cavity was observed in the lower portion of the stem 12-feet from grade level as well as swelling in the stem below the cavity (appendix B photo 18). When the stem was sounded changed in pitch indicated portions of the stem below the cavity may be hollow and or decayed. The root crown area on the north side of the tree shows areas of swelling as well as a vertical seam which can indicate decay (appendix B photo 19). Some damage to the buttress roots was observed on the south side of the tree (appendix B photo 20).

Potograph #17: Tree #3 Recent pruning cuts, codominant structure.

Tree #3 Perform a level 3 investigation to inspect codominant structure, upper canopy, previous large diameter branch failure. Wood resistance drilling and or sonic tomography is also recommended for the stem, root crown and codominant intersection.
