Tree Risk Assessment

Town of Westport Public Works
110 Myrtle Ave
Westport, CT 06880

Jesup Green
20 Jesup Rd.
Westport, CT 06880

April 8, 2024

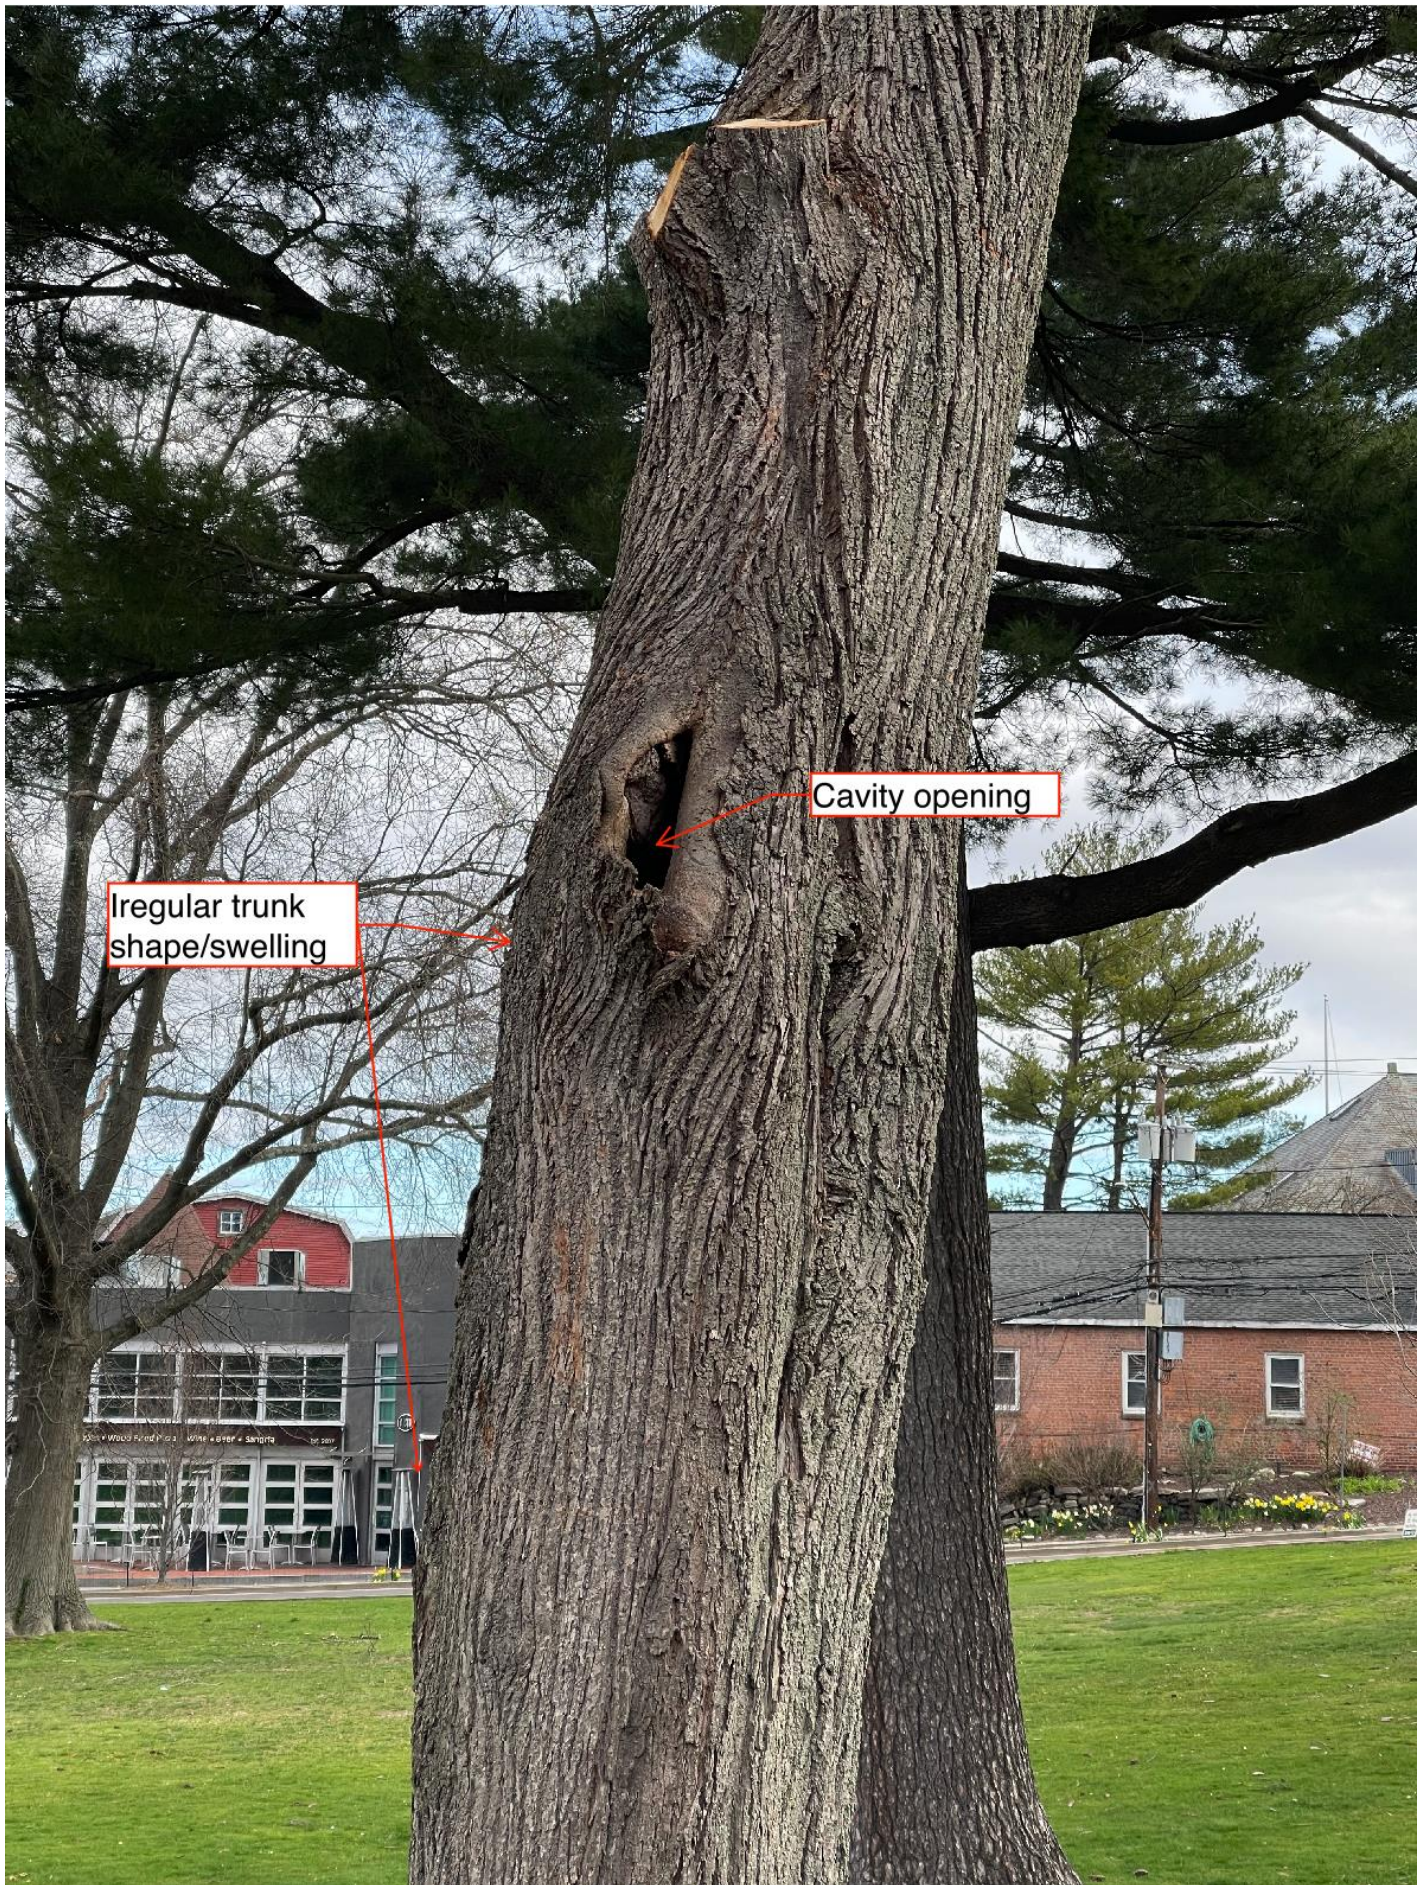
The Linden tree is located south of tree #2 and adjacent to the library. It measures approximately 85-feet tall and has a 38-inch DBH. The tree also has codominant structure and has been recently pruned (appendix B photos 16 and 17). The tree leans to the west 3 to 8 degrees. A cavity was observed in the lower portion of the stem 12-feet from grade level as well as swelling in the stem below the cavity (appendix B photo 18). When the stem was sounded changed in pitch indicated portions of the stem below the cavity may be hollow and or decayed. The root crown area on the north side of the tree shows areas of swelling as well as a vertical seam which can indicate decay (appendix B photo 19). Some damage to the buttress roots was observed on the south side of the tree (appendix B photo 20).

Potograph #18: Tree #3 Recent pruning cuts, codominant structure.

Tree #3 Perform a level 3 investigation to inspect codominant structure, upper canopy, previous large diameter branch failure. Wood resistance drilling and or sonic tomography is also recommended for the stem, root crown and codominant intersection.

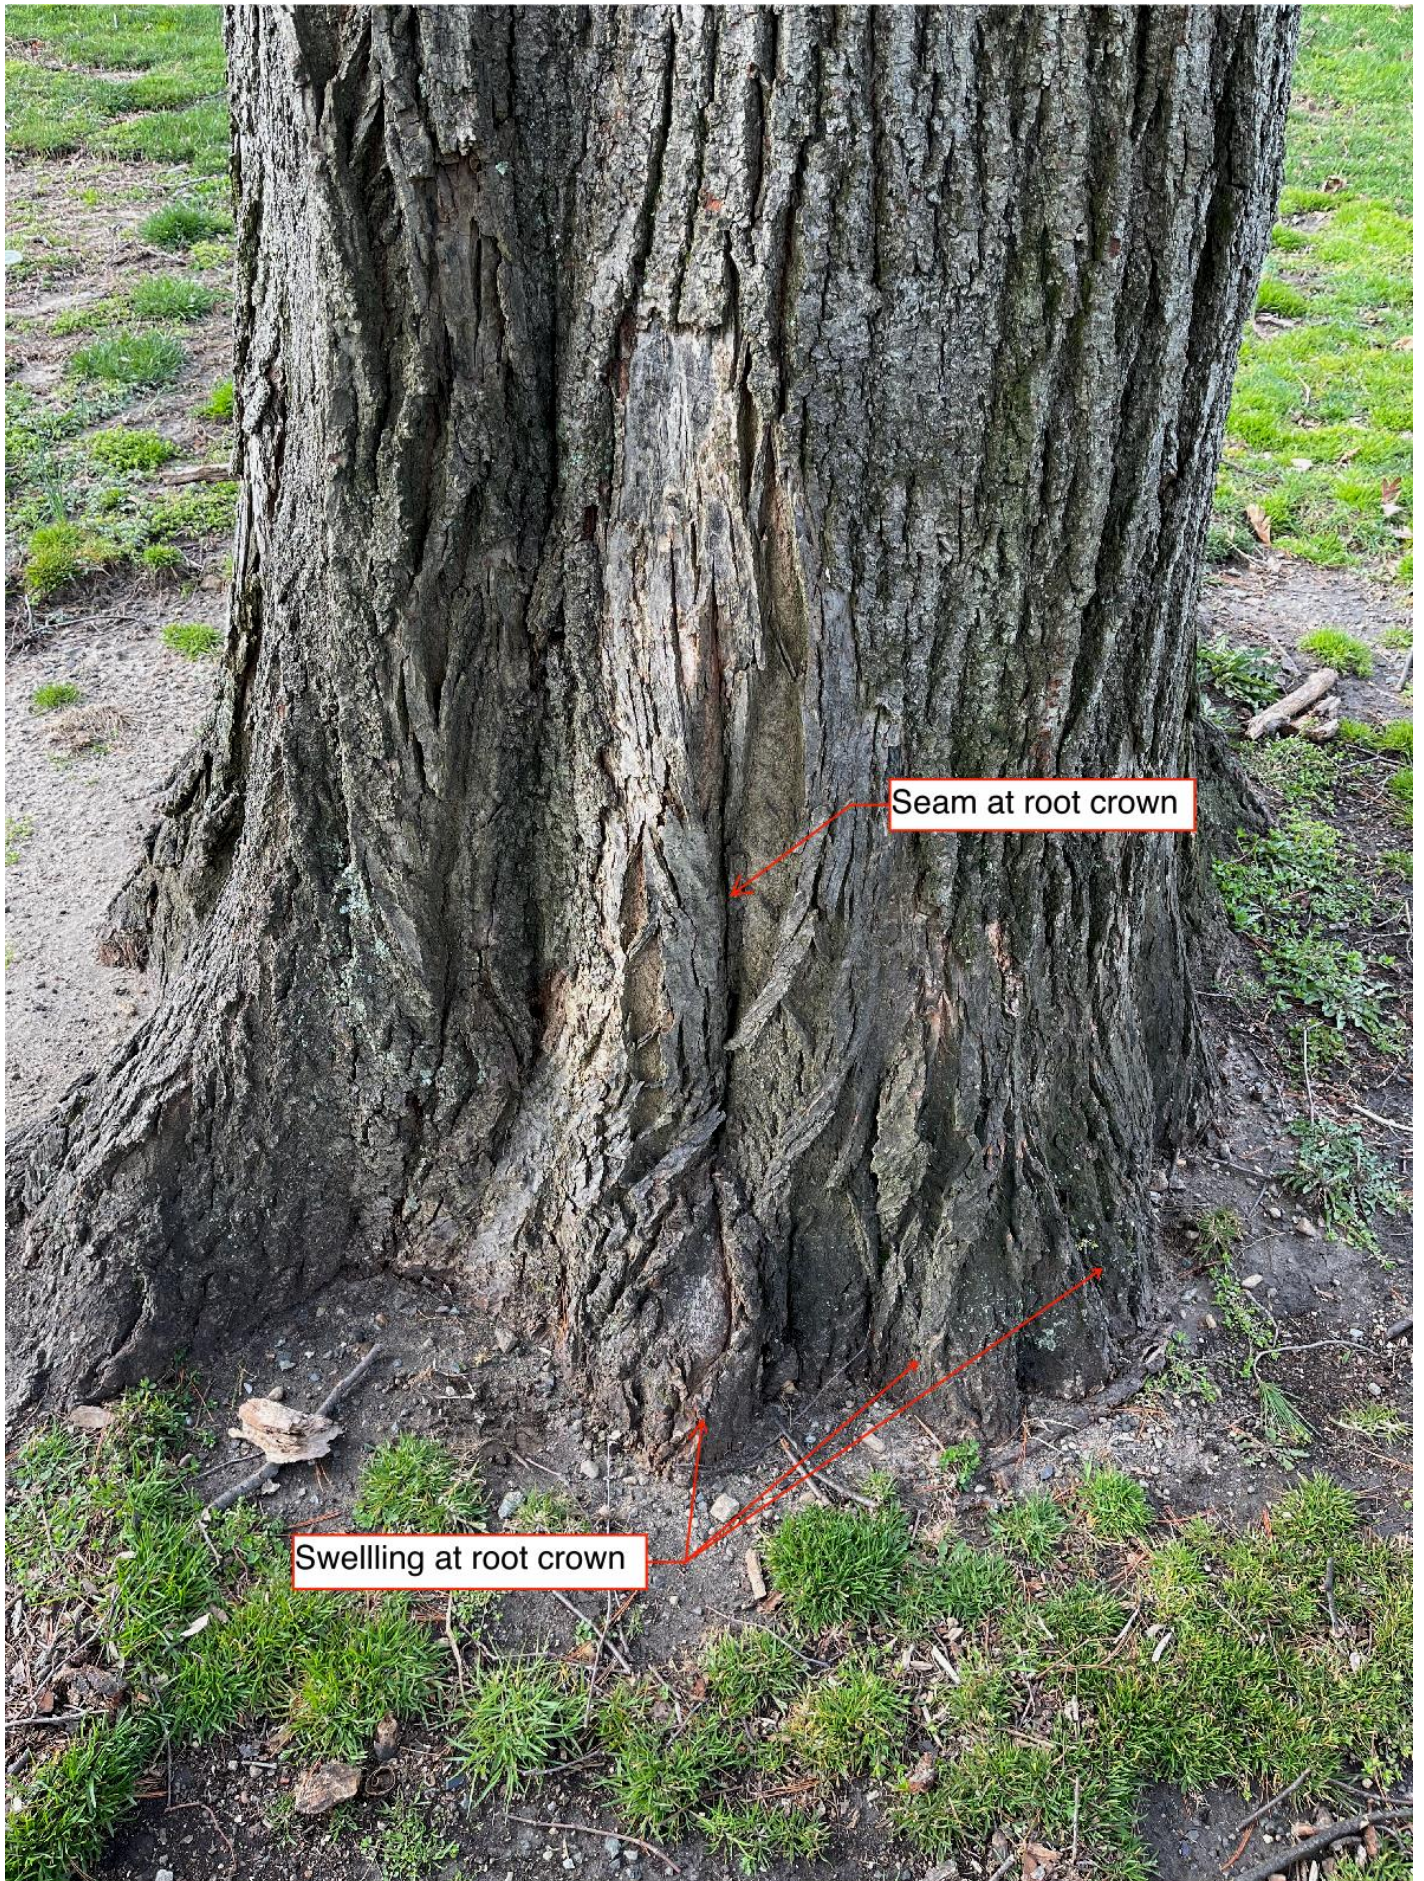
Seam at root crown

Swelling at root crown

Potograph #19: Tree #3 Vertical seam and swelling.

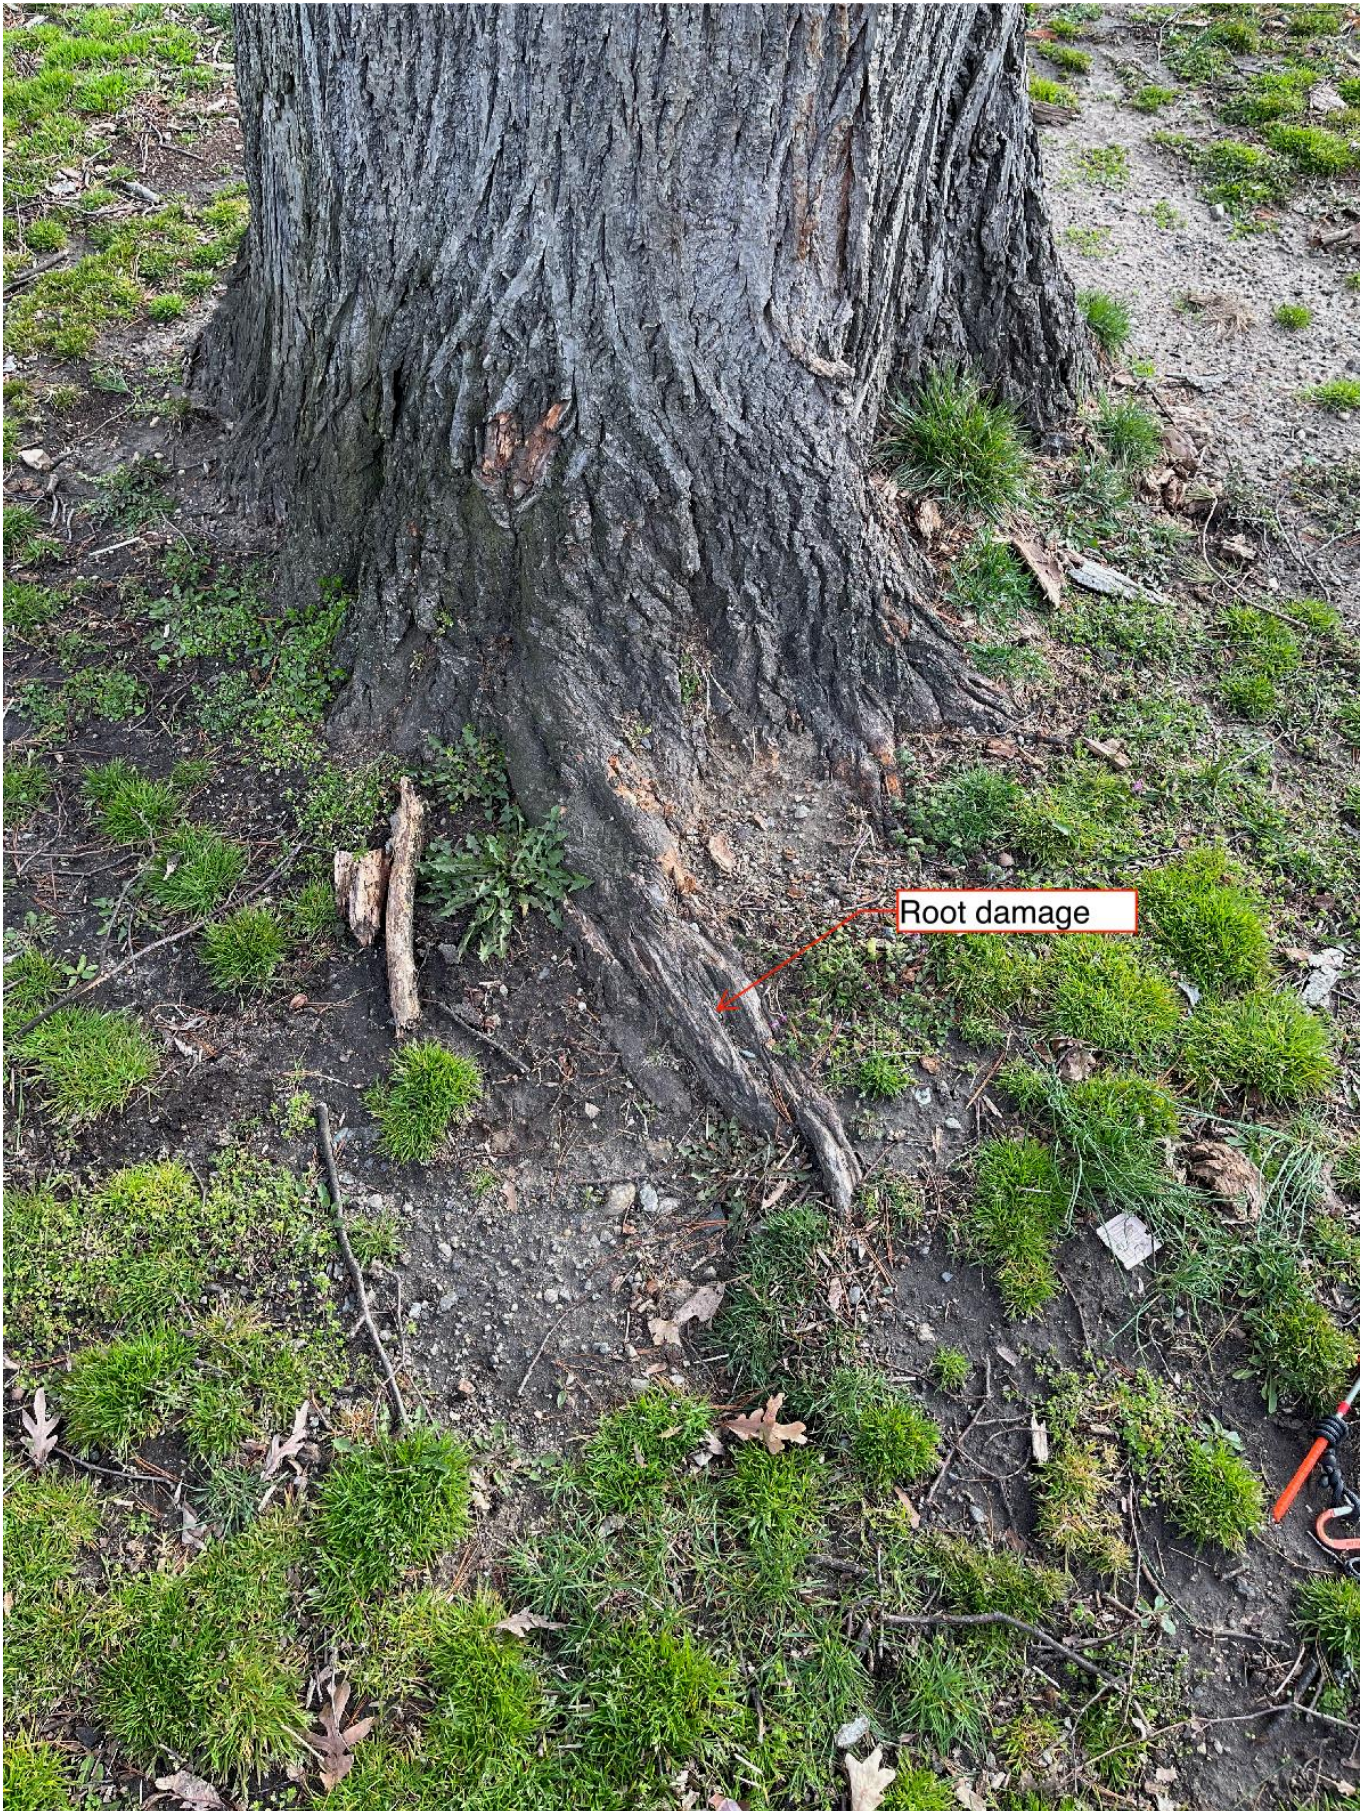
Potograph #19: Tree #3 Vertical seam and swelling.
