Downtown Westport Master Plan  
Phase I – Traffic & Transportation Study  
TOWN OF WESTPORT, CT

TECHNICAL MEMORANDUM #1  
**Existing and Future Baseline Conditions**

June 2014

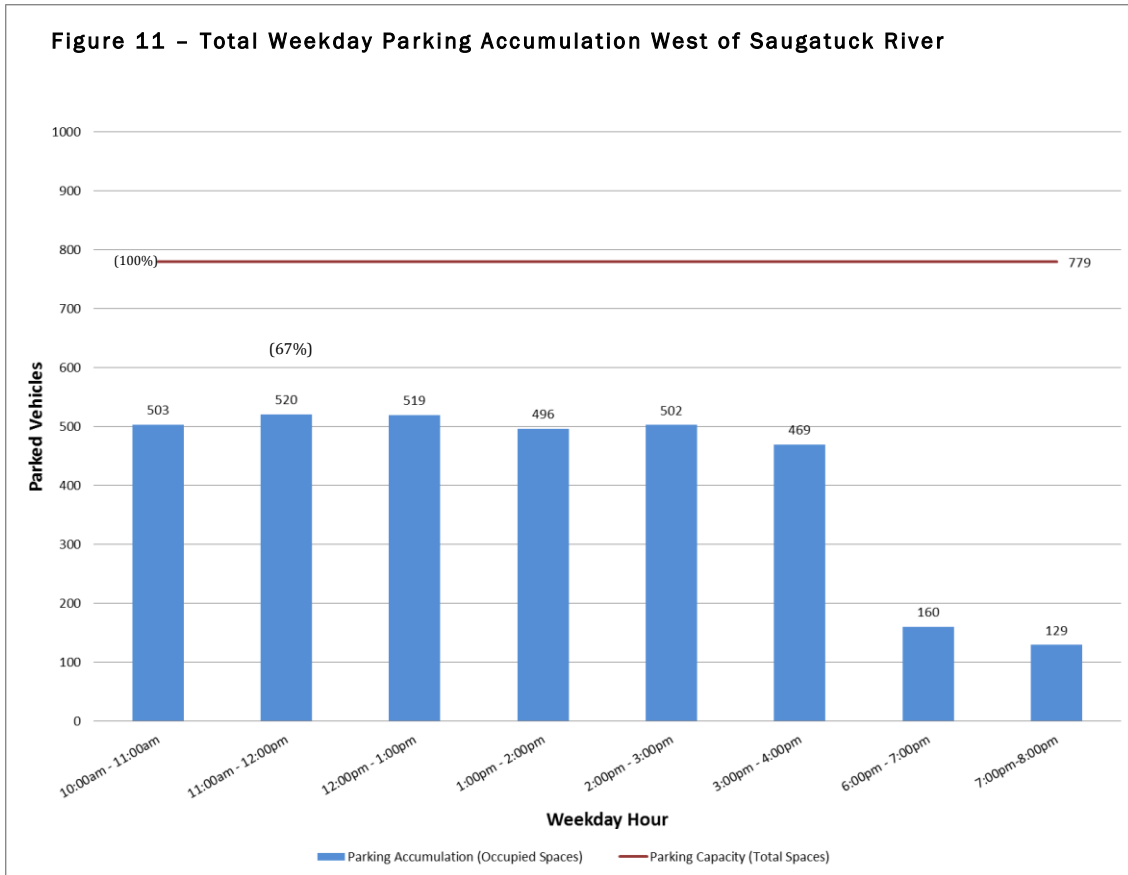
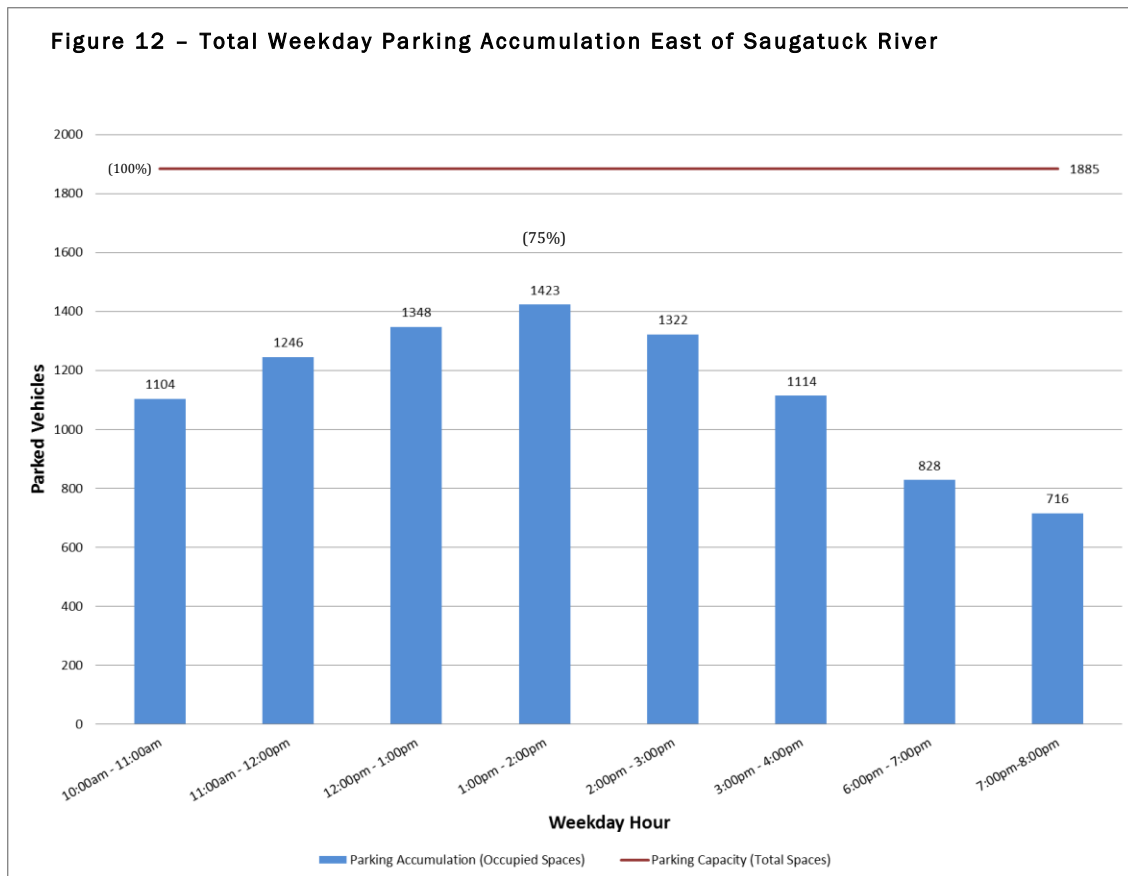
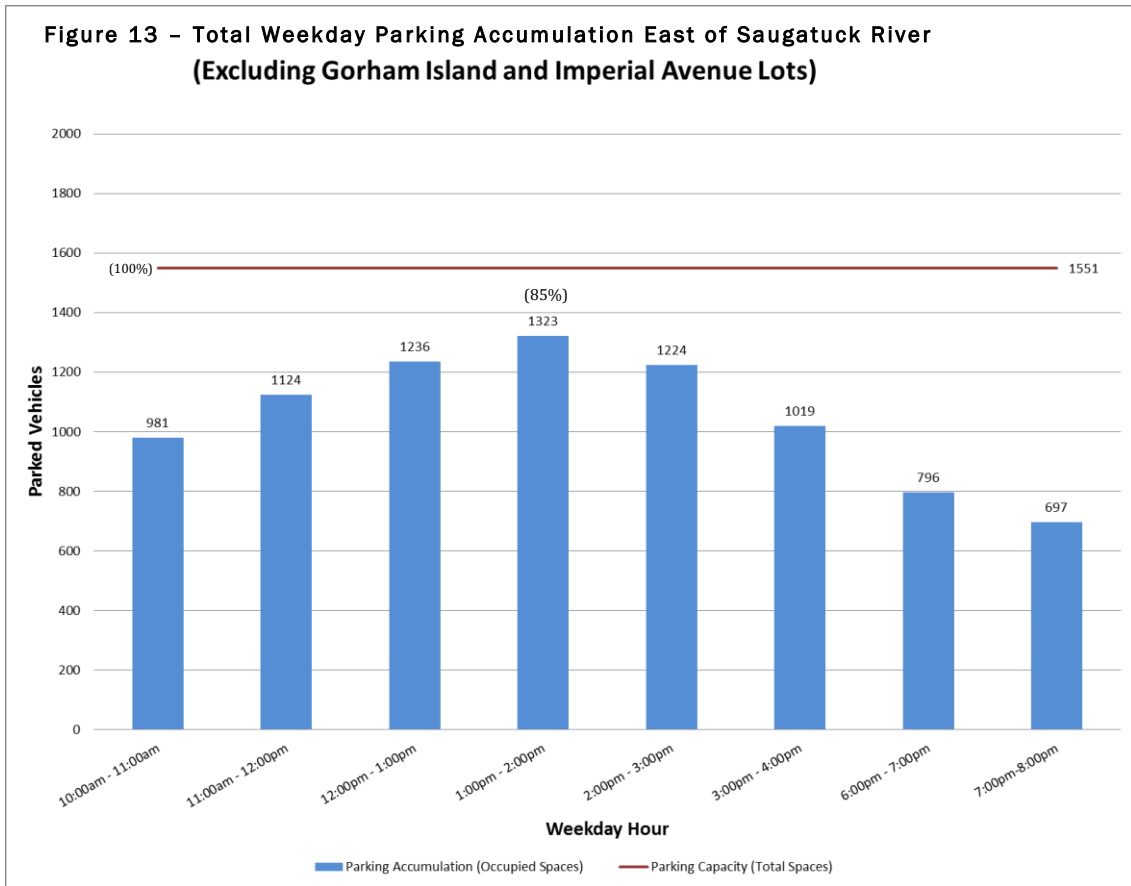
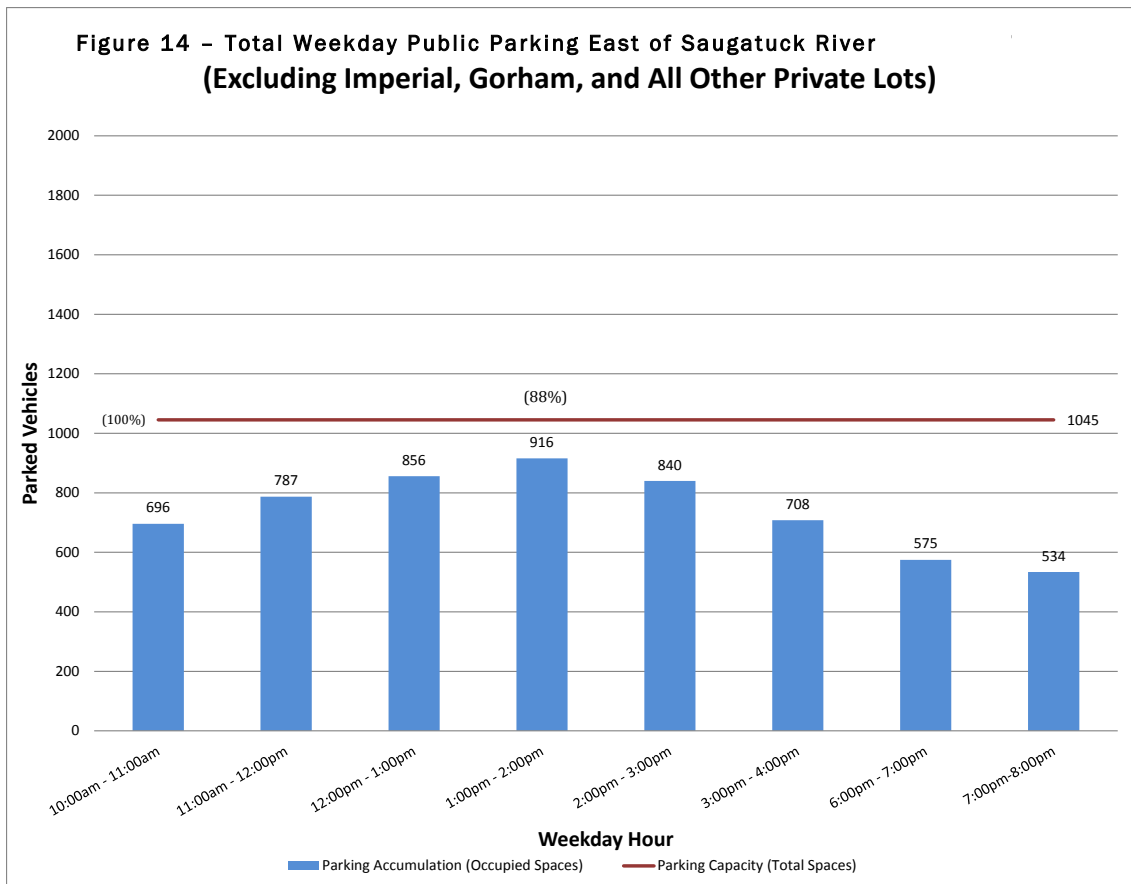
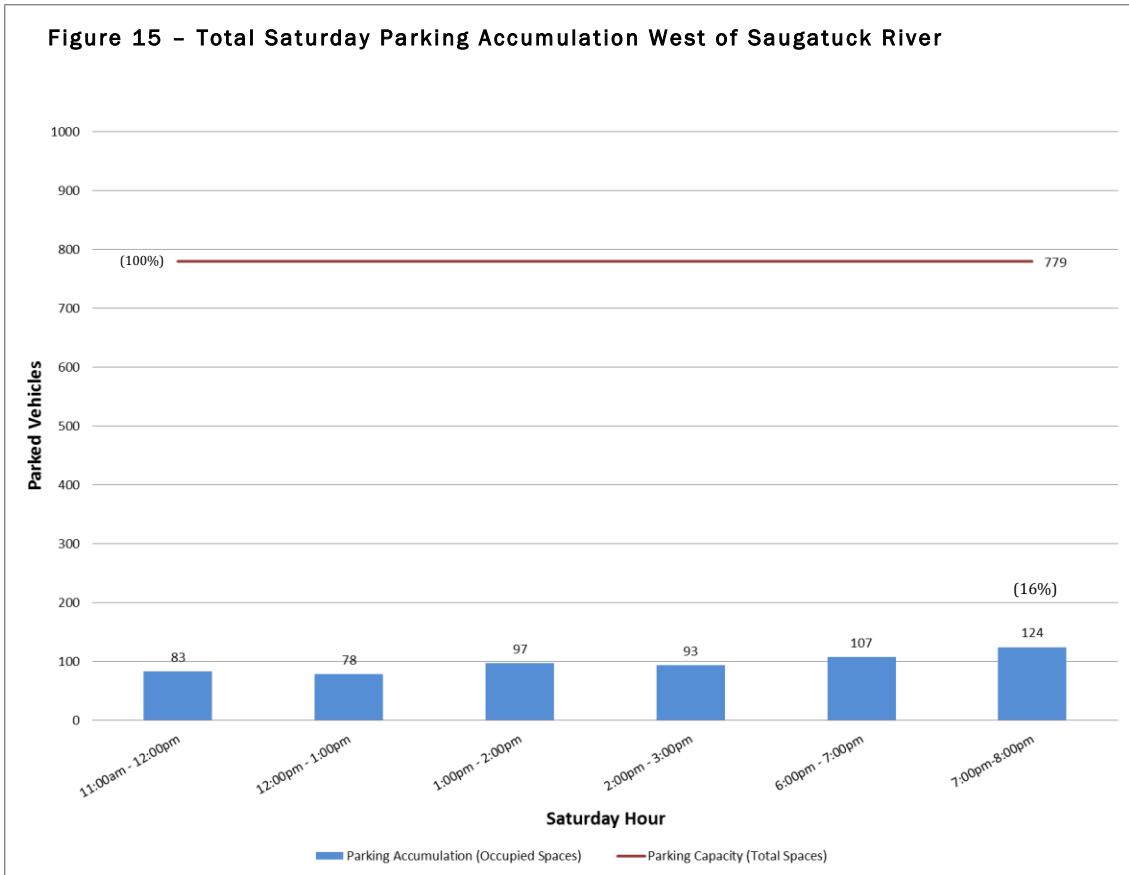
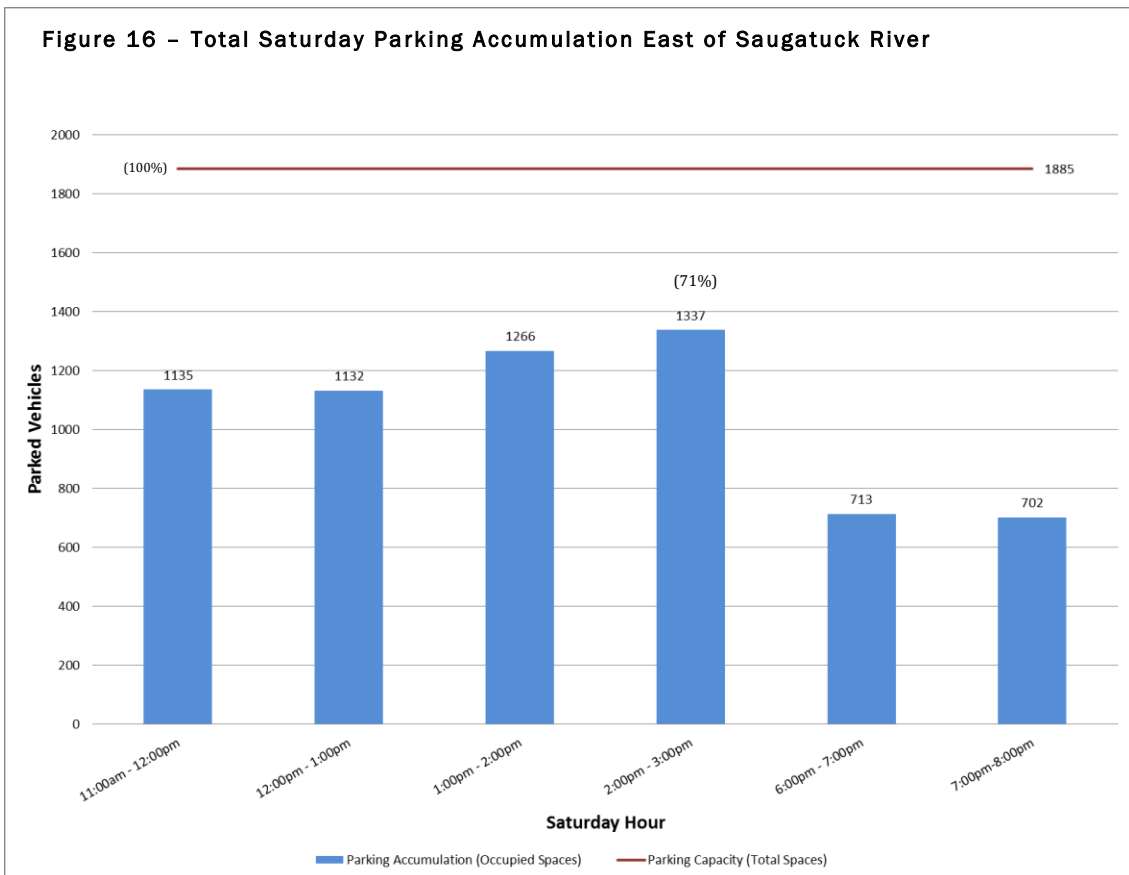
The results of the parking survey are summarized in *Figures 11* through *18*. These bar charts show the totals by hour for the downtown areas west of the Saugatuck River and east of the river. There are four charts for the typical weekday, and four for the typical Saturday. There is a chart for the downtown area west of the river, a chart for the downtown area east of the river, a chart for the area east of the river excluding the Gorham Island and Imperial Avenue lots (to illustrate parking availability in the immediate downtown area), and a chart for the area east of the river excluding the Gorham Island and Imperial Avenue lots as well as all private lots (to illustrate *public* parking availability in the immediate downtown area). As the figures show, the parking utilization throughout the downtown does not reach 100 percent during a typical day even during the peak hours.

During the typical weekday, the parking utilization on the west side of the Saugatuck River peaks between 11:00 am and 12:00 pm with approximately 520 spaces occupied out of 779. This represents about 67 percent of available spaces on the west side of the river. The parking utilization on the east side of the Saugatuck River peaks between 1:00 pm and 2:00 pm with approximately 1423 spaces occupied out of 1885. This represents about 75 percent of total available parking spaces. In order to account for the preferences of drivers to minimize the walking distance from their parked vehicle to their destination, the utilization data for the east side was analyzed again, omitting the Gorham Island and Imperial Avenue lots. Given the distance of these lots from downtown destinations, drivers are typically less likely to use them. When the Gorham Island and Imperial Avenue lots are excluded from the analysis, the total number of occupied spaces on the east side of the Saugatuck River between 1:00 pm and 2:00 pm becomes approximately 1323 spaces, or 85 percent of available spaces. When all privately-owned lots as well as the Imperial Avenue and Gorham Island lots are excluded from the analysis, the total number of occupied spaces on the east side of the Saugatuck River between 1:00 pm and 2:00 pm is approximately 916 spaces, or 88 percent of available spaces. Although this is a higher share, this indicates that the current demand within the extended parking study area does not exceed parking supply.

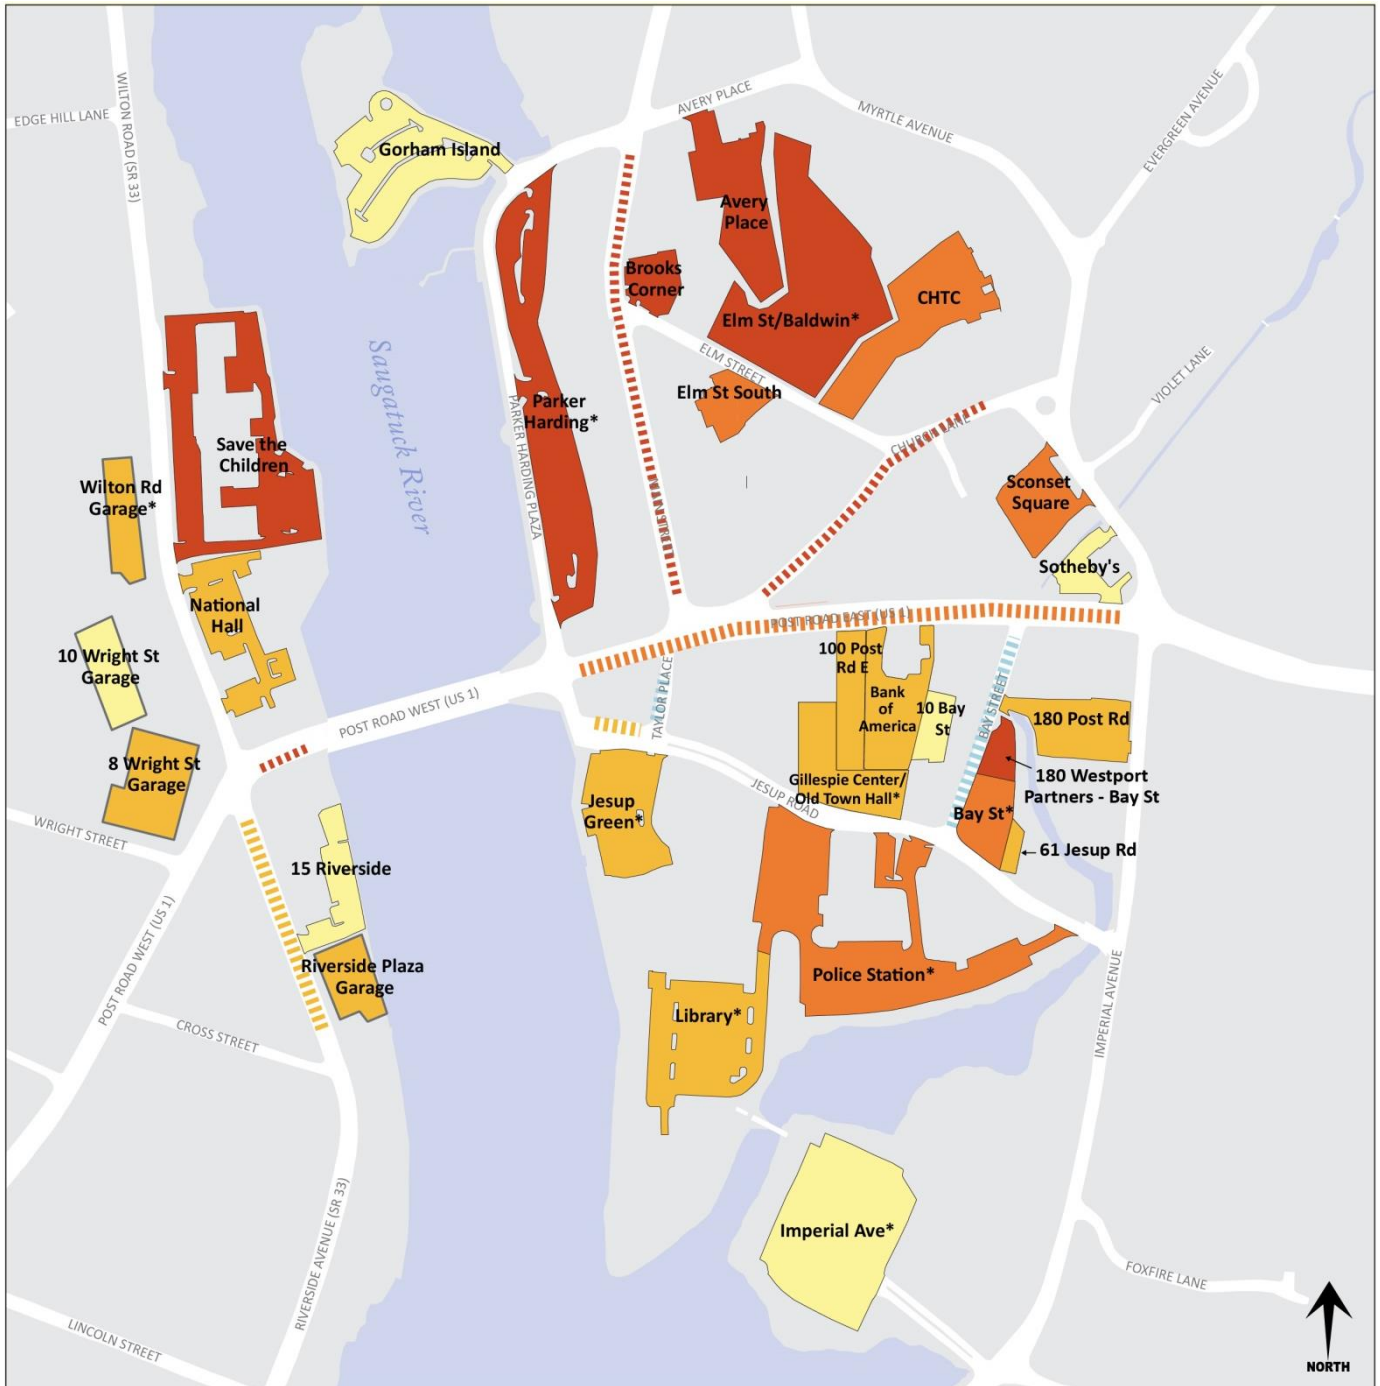
Figure 19 - Existing Weekday Midday Peak Hour (1-2PM) Parking Utilization

*Figures 19 through 22 illustrate parking availability in the immediate downtown area, in which the results of the parking survey are shown overlaid on a map of the downtown area. These figures provide a more nuanced breakdown of parking conditions throughout the study area, by showing parking utilization for each lot individually. Each figure shows every parking area color-coded according to its degree of utilization. The worst-case periods are shown: the midday and evening peak hours on a typical weekday, and the midday and evening peak hours on a typical Saturday. On the west side of the river, the parking supply is clearly sufficient to contain the demand. On the east side of the river, although the parking supply exceeds the demand, parking utilization varies greatly depending upon the distance from downtown as well as the ownership of the parking facility.*

As noted above, and shown in *Figures 19* through *22*, the utilization of a parking facility varies depending upon the distance from downtown as well as the ownership. It is worth noting that although the utilization is clearly clustered in the downtown, there is still sufficient parking supply within a quarter-mile radius of the downtown area. A quarter-mile radius is generally accepted by planners, engineers and architects as corresponding to an approximately five-minute walk. It is used to define a reasonable walking distance based on a willingness among the general public to walk 5-10 minutes to or from a parking space or transit stop to a destination. A five-minute walk is also used as a standard to describe the average distance that a pedestrian is willing to walk before opting to drive.

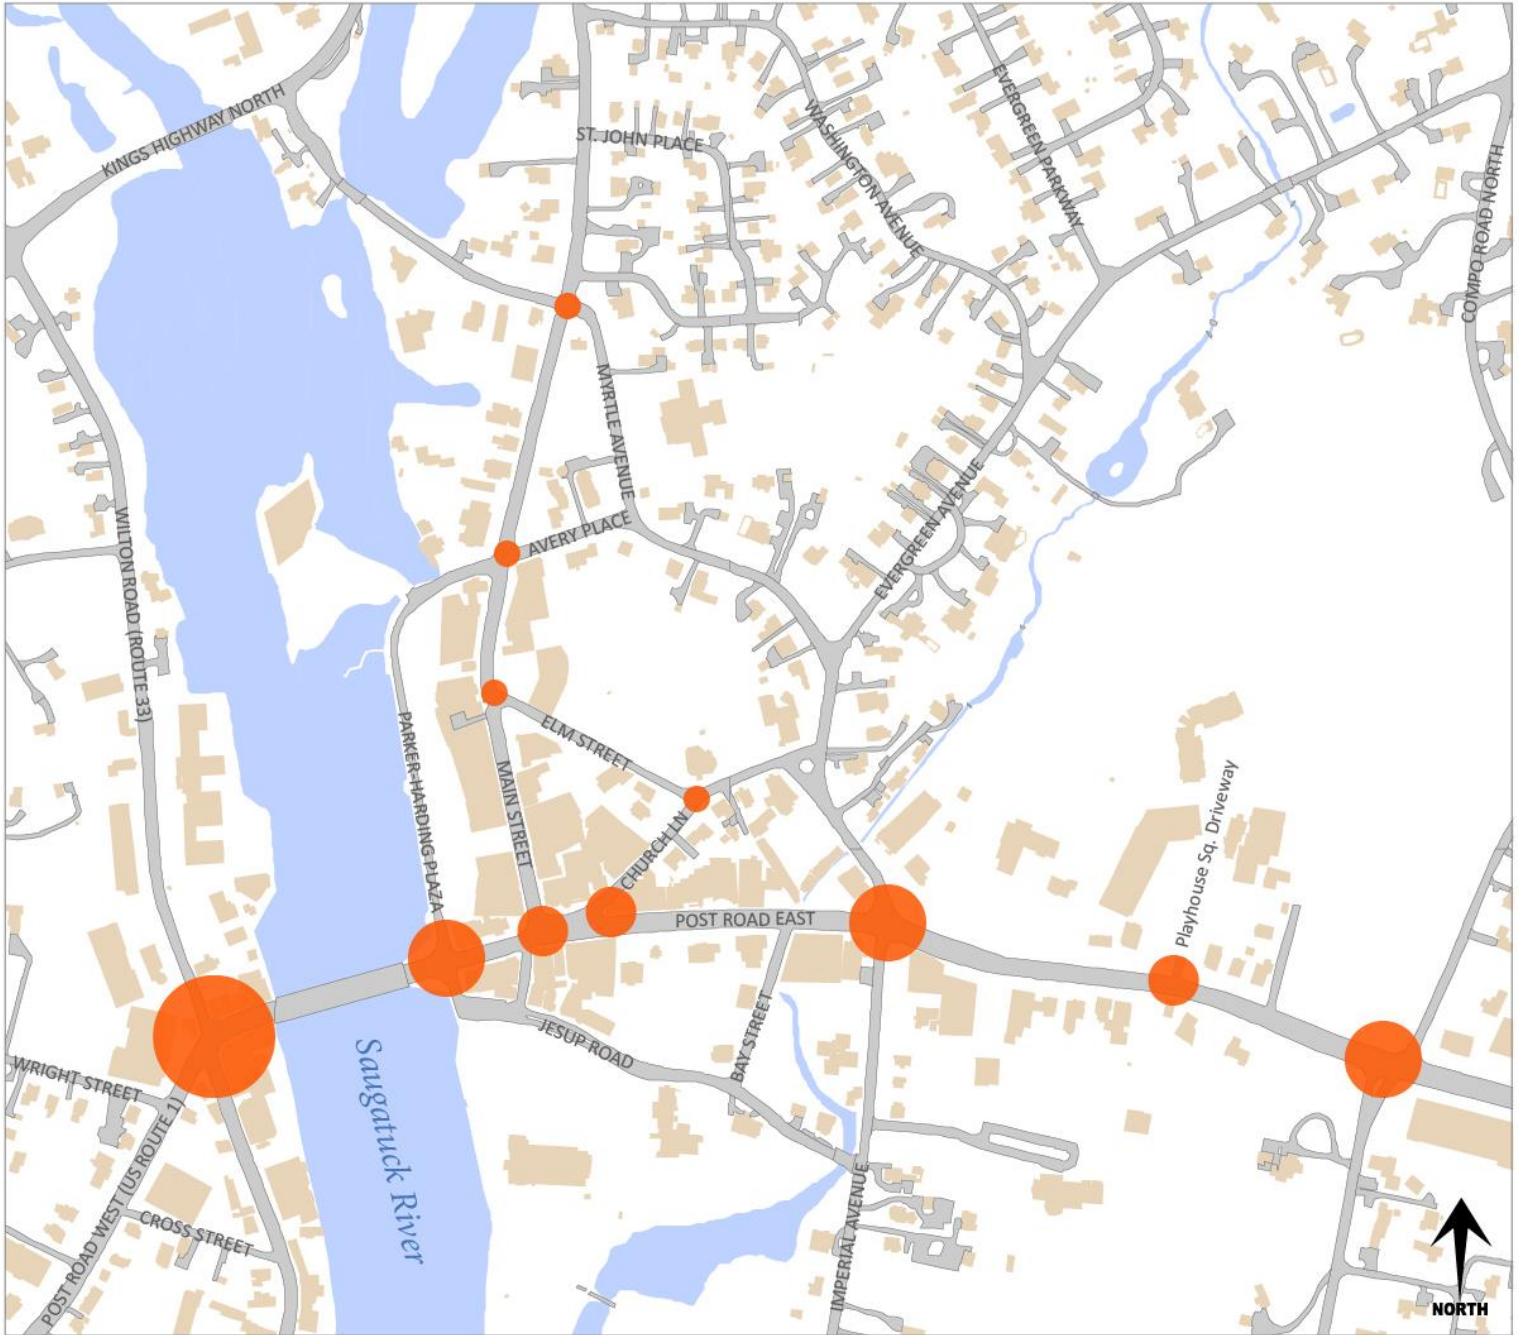
Figure 24 – Accident Frequency Map

**FREQUENCY OF TRAFFIC ACCIDENTS AT INTERSECTIONS**  
 Downtown Westport Master Plan Town of Westport, CT
